# Utilization of Zirconium Oxide in Fixed Restorations on Implants and Natural Teeth—a Case Report

author\_Axel Zöllner, Claus Diemer, Germany

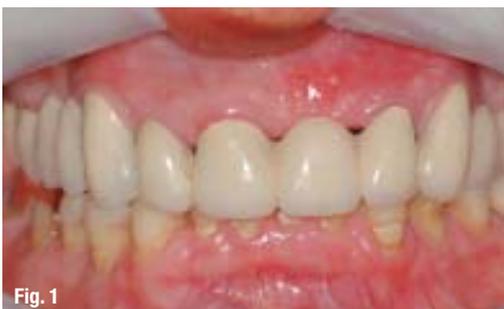
Fig. 1

**Fig. 1** Initial situation, aesthetically and functionally insufficient dental prosthesis..

a clinical perspective, that some of the crowns has loosened, some of the ceramic veneers had chipped and that there were caries lesions at crown margins, so that the current condition had to be deemed insufficient (Fig. 1). We made photographs and constructed models in order to make a detailed analysis or modification recommendations, respectively.

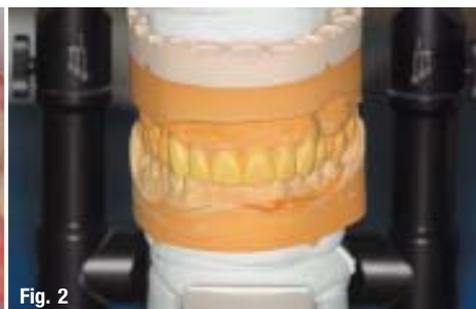
Fig. 2

**Fig. 2a/b** Wax-up on situational models to simulate possible future treatment results.

The mounted models and photographs we provided, gave the dental technician the first opportunity to assess the situation, possible problems and feasible results. In the present case, we created a wax-up of the front teeth (Fig. 2) to produce a planning device by using a doubling and a flexible brace (Copyplast/Scheu-Dental), which was stabilized with a plaster key to be inserted in the palate (Fig. 3a/b).

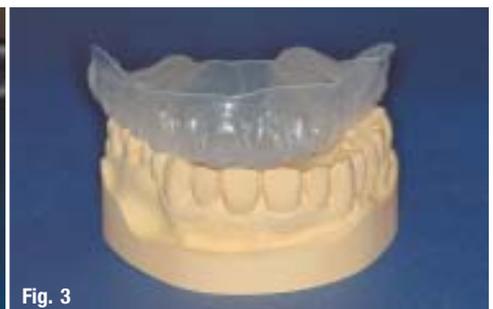
Fig. 3

**Fig. 3a/b** Transfer of the wax-up into a vacuum-formed template to create temporary devices.
