Resorption mechanism of an injectable calcium phosphate bone regeneration cement—Radiographic and histological monitoring

author_Sérgio Alexandre Gehrke, Brazil

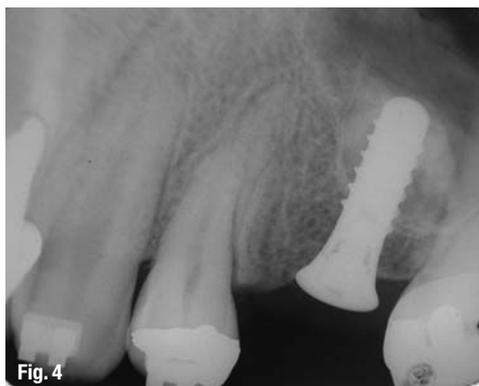
Fig. 2 Illustration of the installation of the first cement portion, against the inner wall of the sinus cavity.

After administration of a local anesthetic, a lateral access to the sinus cavity was performed through a lateral window. Then, the sinus membrane was carefully lifted up to the desired height. The drilling of the site was performed according to the recommendations of the manufacturer. During this phase, particular attention was paid to avoid perforating the membrane with the drills. A gaze humidified with a vasoconstrictor solution was placed into the sinus cavity for five minutes to control the bleeding as efficiently as possible. Indeed, blood flow must be avoided during injection of the PD VitalOs cement in order to allow contact between Cement and bone and anchoring of VitalOs onto the sinus wall. Then, the cement was injected into the sinus to fill the space between the inner (nasal) wall of the cavity and the space prepared for the installation of the implant (Fig. 2). Once the cement was hard, the implant was installed as planned. Finally, the rest of the cavity was filled up with VitalOs up to the edges of the lateral window, without using a membrane. Indeed, the use of a membrane is not necessary with VitalOs, since the product acts itself also as a barrier.

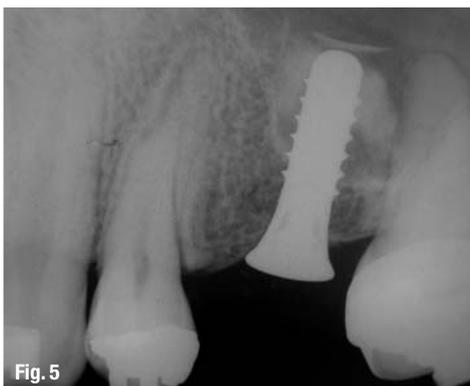
Fig. 3 Sinus cavity completely filled with VitalOs, after installation of the implant.

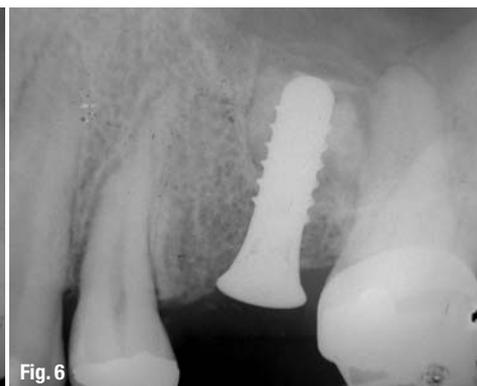
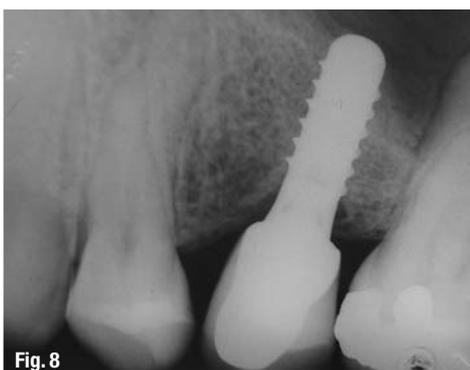
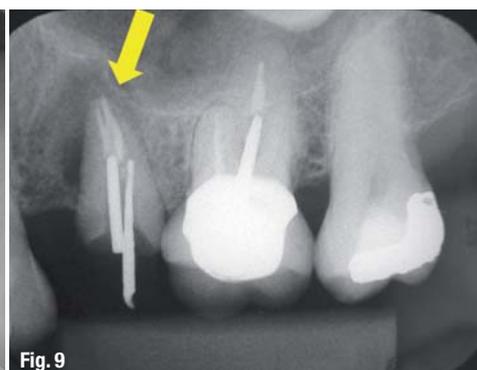
Fig. 4–7— Radiographs of case I at 30, 60, 120 and 180 days after surgery.

Thanks to the adequate radiopacity of the cement, it is easy to perform a radiographic follow-up and analysis of the resorption and new bone growth. Radiographs were therefore taken at 30, 60, 120 and 180 days after implant installation (Figs. 4–7), as well as 12 months (Fig. 8) after installation of the

VitalOs cement. This process progresses towards the center of the cement mass. In the sinus lift case, the progress also takes place from the coronal towards the apical region around the implant (yellow arrows on Figure 4). Across the different times of analysis it is possible to see that the material is gradually being replaced and the osseous tissue is being formed, apparently without incorporation of cement particles. At the end of the neoformation process, the newly formed bone displays radiographic characteristics which are similar to those of the native surrounding bone. This is also confirmed after 12 months of loading, where the bone around the implant has not resorbed, indicating a good preservation of the new osseous volume around the implant.

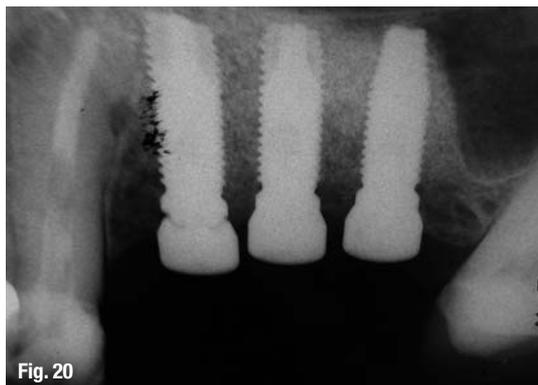
Fig. 20

Fig. 20, 21_Radiographs of a case augmented with Bone Ceramic: 180 days after surgery and one year after crown installation, respectively.

The radiographic monitoring is more difficult to achieve with granular materials because their appearance on radiographs is closer to that of bone and the grafted area becomes eventually a mix of granules and bony tissue. To emphasize this, Figures 20 and 21 show radiographs of sites augmented with granular materials (Bone Ceramic), 180 days after augmentation and one year after crown installation, respectively. It can be seen that the newly formed bone is not as well defined as in the cases filled with the brushite cement (Fig. 15). The resorption mechanism of granular materials is also accompanied by new bone formation, but this takes place between the granules, most of them remaining eventually embedded in the new bone structure.
