Buccal dehiscence and sinus lift cases

Predictable bone augmentation with synthetic bone material

Authors_ Dr Sérgio Alexandre Gehrke, Brazil & Dr. Giuseppe Maria Famà¹, Italy

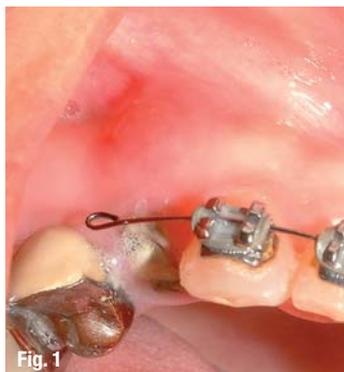
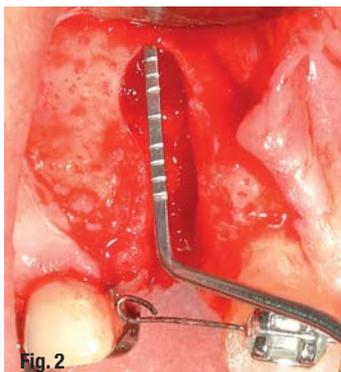
ograph as well as clinically (Fig. 1). The facts that the fracture was old and that a fistula developed around the root resulted in a large loss of the buccal bone wall. The treatment options were presented to the patient, who signed an informed consent form. The patient presented no contra-indications to the treatment.

markings (Figs. 2 & 8). The implants placed were in each case a Straumann RN SP (4.1 mm diameter, 14 mm length). The implants were installed at the level of the crestal bone of the adjacent teeth.

The injection of VitalOs must always be preceded by adequate control of the bleeding with the suction canula. The cement is placed within the defect without need for over-filling (Figs. 3 & 9), unlike what is often done with other types of bone substitutes like granules. Any material put in excess is always expelled or resorbed. With VitalOs, as the cement forms a block, a large quantity or even the whole material may be expelled. When the injected quantity is in large excess, the hardened block can easily break up and large pieces may be expelled out of the site. With granular materials it is only small granules that are expelled and this is less disturbing than pieces of cement. This is the reason why we never overfill sites with VitalOs.

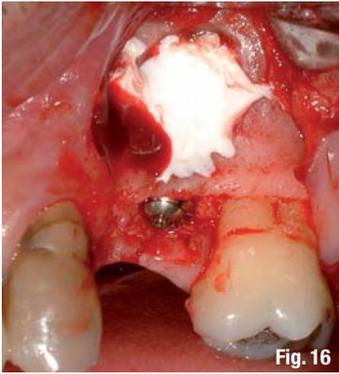
stitches. A post-operative radiograph was taken 7 days after surgery (Fig. 17). The distance between the sinus floor and the implant apex was measured on the radiograph. The results are shown in Table 2. The patients were recalled after one year to take a radiograph of the treated sites (Figs. 15 & 18).

Table 2 shows the values measured post-operatively and one year later.

We already observed that the process of resorption of the cement coupled with new bone growth can be conveniently followed up radiographically (Gehrke 2009). One year after functional restoration we could see that the level of newly formed bone was maintained, without loss around the apical portion of the implants. This is a very positive finding because the loss of bone at the apical level after loading the implants is a common phenomenon when this type of sinus grafting is performed.
