# Peri-implantitis prophylaxis by sealing implant gaps and hollow spaces

**Author**\_Prof. Dr Dr Claus Udo Fritzemeier, Germany

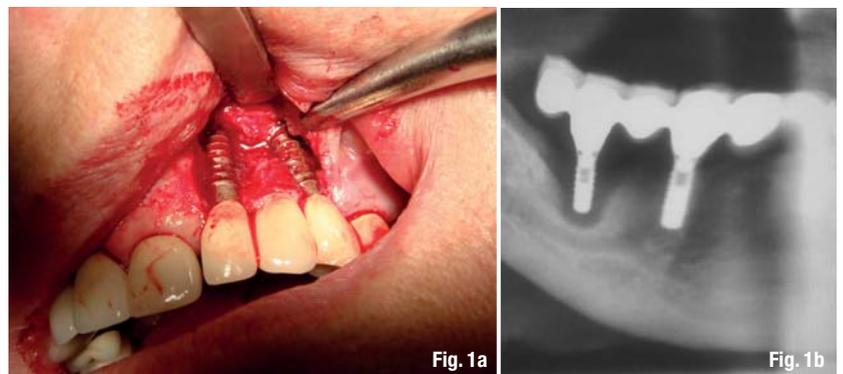
**Fig. 1a**\_Peri-implantitis, clinically.  
**Fig. 1b**\_X-ray of peri-implantitis.

Against this background, implantology with all its prosthetic treatment varieties is considered an established method. One of the most common and most feared complications occurring in implantology is peri-implantitis (Figs. 1a & b), which usually leads to implant loss when it remains untreated.

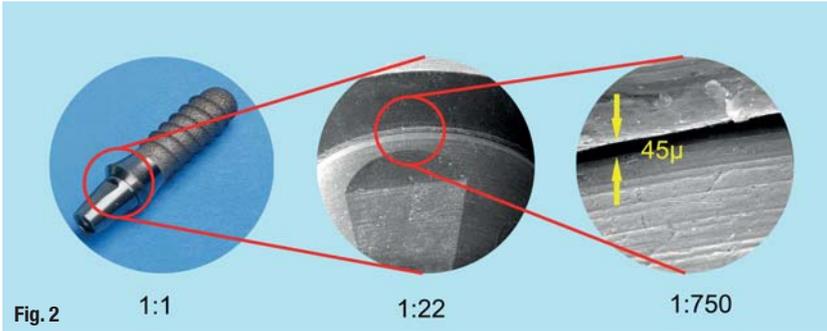
Fig. 2

**Fig. 2\_** Used implant randomly chosen, on which the marked area was light and electron microscopically examined (Brand is unnamed intentionally).

The access paths of germs into the implant interior are easily comprehensible, and we were able to provide evidence by taking light and electron microscopic exposures of a used implant (Fig. 2). The paper "Implant Component Compatibility" by Binon et al. confirms this matter quite impressively.<sup>3</sup> The results showed that the macroscopically good fit re-

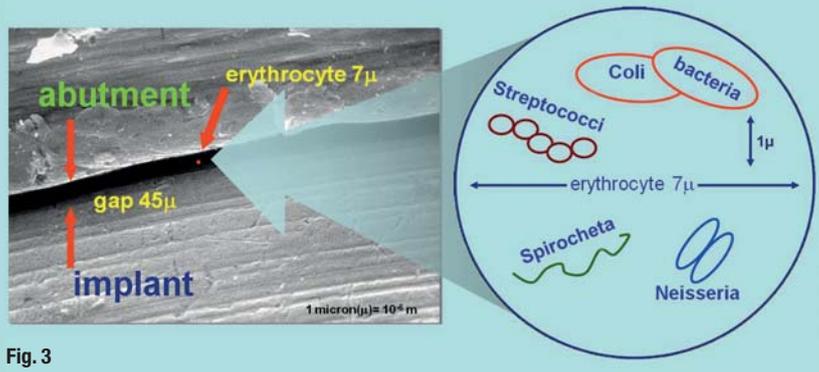
Fig. 3

**Fig. 3\_** Gap situation between implant and abutment compared to an erythrocyte with a diameter of 7  $\mu$  ( $1 \mu = 10^{-6} \text{ m}$ ), 745 times enlarged. The randomly chosen germs are depicted true to scale and compared to an erythrocyte.

Furthermore, the capillary forces and micro motions<sup>18</sup> between implant and abutment promote the exchange of infectious material, for which saliva is a good vehicle. Figure 3 shows the proportion of the gap located between implant and abutment compared to an erythrocyte.<sup>7</sup> In order to make the dimensions even more clearly, the randomly chosen germs shown are also matched to an erythrocyte exactly to scale.<sup>13</sup>

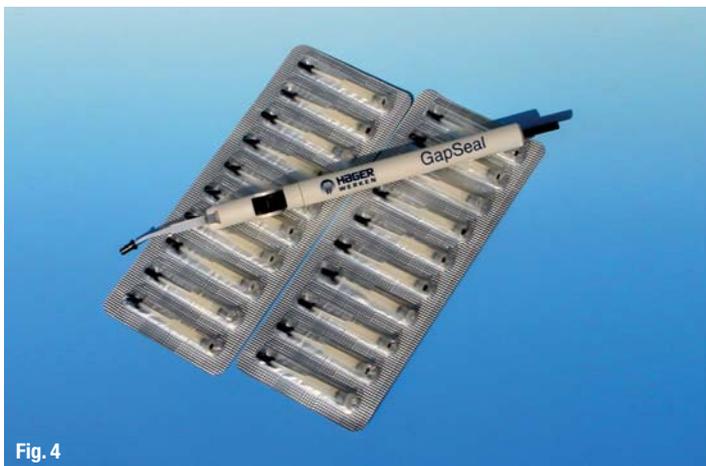
Fig. 4

**Fig. 4\_** Sterilisable GapSeal<sup>®</sup> applicator with GapSeal<sup>®</sup> carpules.

The sealing material thymol has bactericidal, virucidal and fungicidal properties. It belongs to the microbiologically very effective materials, but is largely harmless to humans. Its disinfecting effect is about 30 times higher than that of phenol, but thymol has only a quarter of its toxicity. It also does not cause allergies.<sup>10,16</sup> The material met its purpose as gap and interior sealant more than satisfactorily and was subsequently named "GapSeal<sup>®</sup>" (Fig. 4).<sup>6</sup>

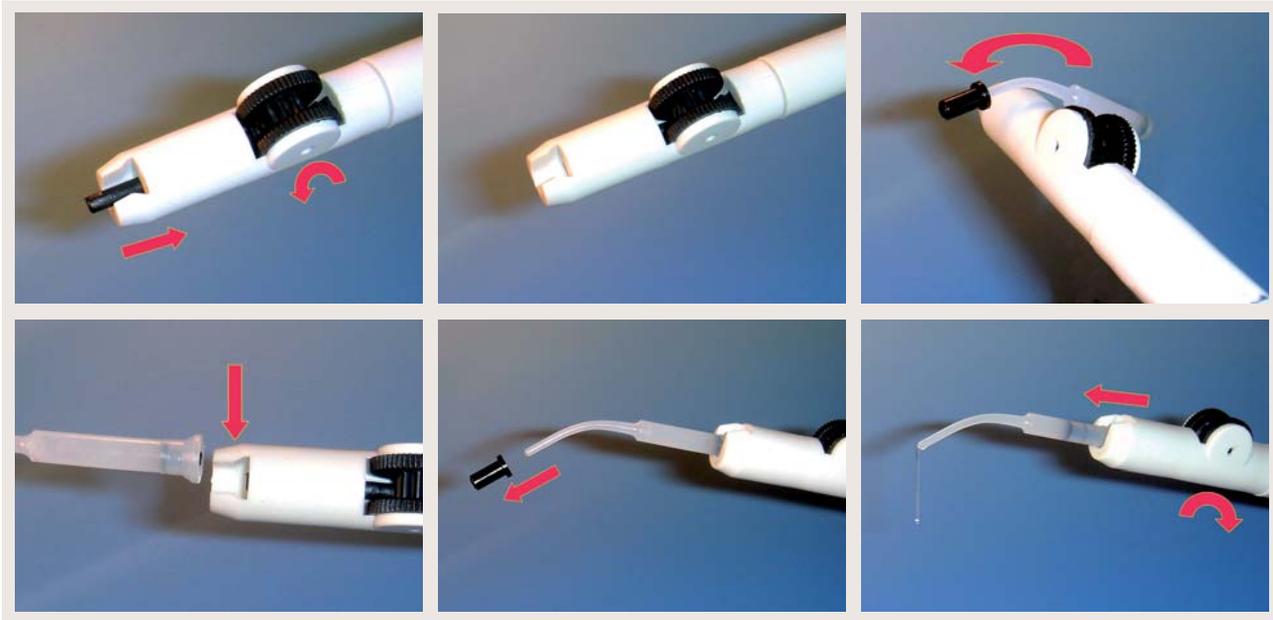
**Fig. 6** Use of applicator and carpules.

Implant interiors can be sealed with GapSeal® immediately after inserting and removing the insertion tool, thereby eliminating the prospective peri-implantitis inducing the re-infection factor. For this purpose, the carpule must be inserted into the applicator at first, and the closing cap needs to be removed. It is recommended to bend the cannula slightly around the applicator shaft according to the filling situation. Excess material gushing from the implant when the closure cap is screwed in indicates a good filling situation (Fig. 6).
