Complete prosthetic restoration in a patient with cleft palate

Authors Dr Michael Peetz & Dr Thomas Hitz

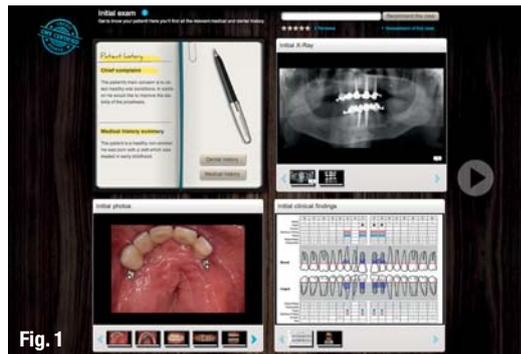
Fig. 1 Screenshot of the initial findings. The case presentation simulates the situation on the desk of the practitioner.

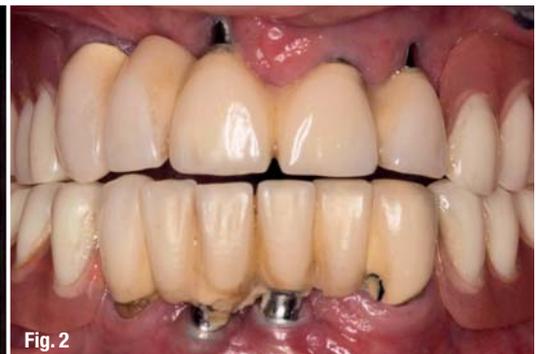
Fig. 2 Initial clinical findings.

The patient, a healthy non-smoker, presents with anterior residual dentition (Figs. 1 & 2). He wishes to have improved oral health and increased stability of his prosthesis. At birth he had a cleft palate, which was treated in childhood. All teeth are missing except 13, 33 and 43, 13 and 43 have been endodontically treated. Four years earlier, in the context of a complete prosthetic restoration, implants were set in positions 11, 21, 22 and 41, 42. Upper and lower jaws have received combined fixed and removable solutions. The patient has an open bite in the anterior region, deficiently short incisors in the upper jaw and an unstable occlusion in the posterior region. Periodontitis is evident and found to be serious in the mandible and moderate to severe in the maxilla. Insufficient oral hygiene has led to plaque accumulation with resulting gingivitis. There are pronounced recessions around the implants with exposed machined and partially exposed rough surface areas. Radiologically, peri-implantitis at implants (Bauer screws) 11, 21, 22 is diagnosed (Fig. 3) with suspicion of a foreign body in region 26. Region 13 shows a failing edge of the crown. Mesial lesions in the crown are detected in region 31, 41.

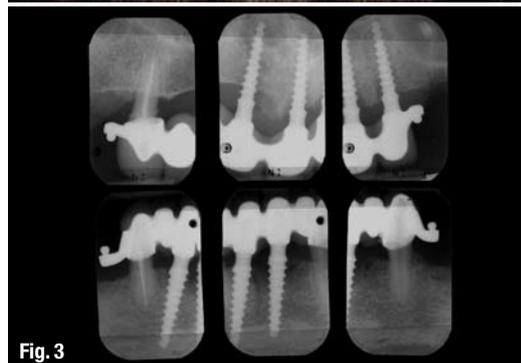
Fig. 3 Intraoral radiographs at initial exam.

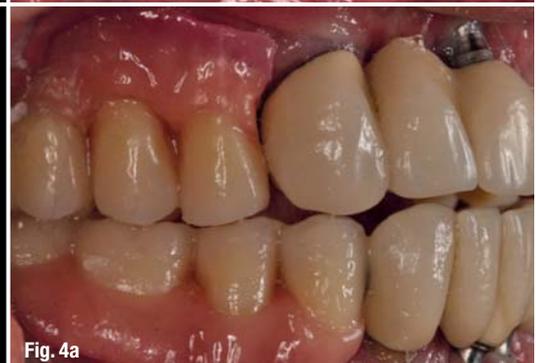
Fig. 4a

Figs. 4a & b Intraoral wax-up with corrected vertical dimension.

After taking the impressions, the vertical dimension in the wax-up is raised (Fig. 4). In the maxilla, the bridge is removed and implants are explanted, tooth 13 is extracted due to a major loss of substance (Fig. 5). Implant 31 is explanted while implant 41 is treated by implantoplasty whereby the coronal aspect is removed (Fig. 6). An explanation would endanger the preservation of tooth 43, due to its location. For this reason, the endosseous portion is left below the cortical bone level. The patient is immediately supplied with a temporary prosthesis. To select the optimal aesthetic tooth shape, two alternative setups for the maxilla are created.

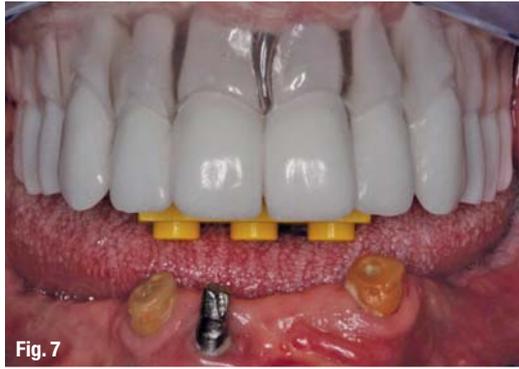
Fig. 7

Fig. 7_The radiographic template is placed in the mouth for the CBCT scan: the Lego brick (yellow) is used as the reference mark.

Implant restorations in the maxilla are performed using computer-assisted navigation (Figs. 7-9). The lacking keratinised mucosa is reconstructed in the maxilla with a palatal graft and a ro-

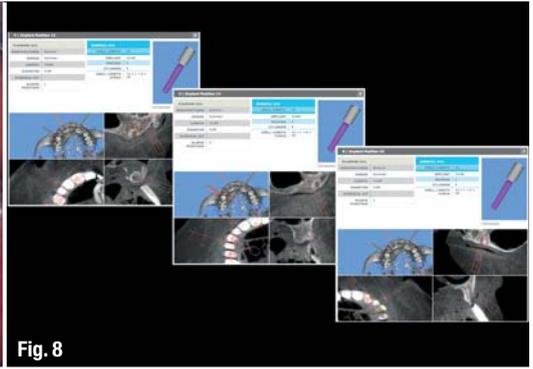
Fig. 8

Fig. 8_Computer-aided planning of implant placement.

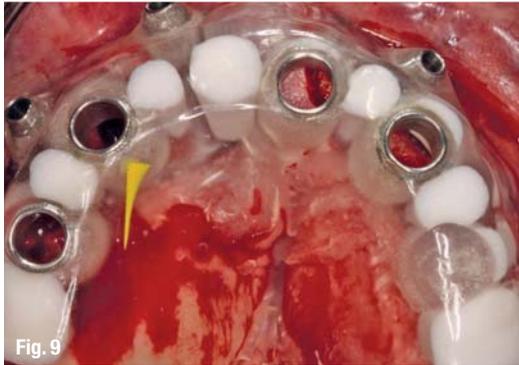
Fig. 9

Fig. 9_Lifted flap with proper placement and fixation of the surgical template.

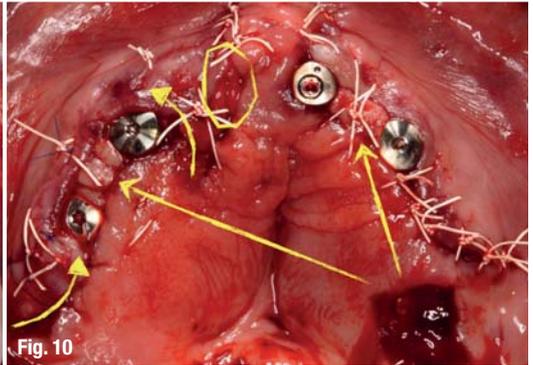
Fig. 10

Fig. 10_Missing mucosa is reconstructed with palatal grafts and rotation flap.

tational flap (Fig. 10). After lifting the flap, the remaining mandibular implant reveals bone loss, due to an inadequately inserted implant (Fig. 11). The implant is cut and left *in situ* to avoid creating a large bone defect by explantation.

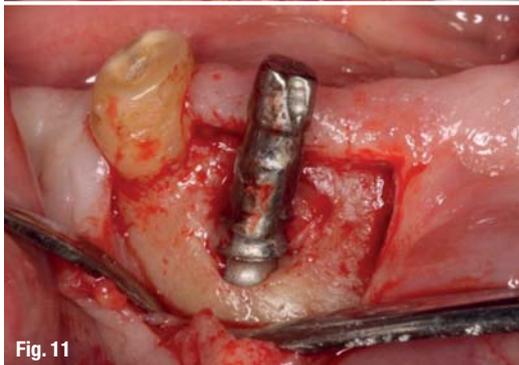
Fig. 11

Fig. 11_The remaining implant in the lower jaw presents with a bone defect. It is cut and left *in situ*.

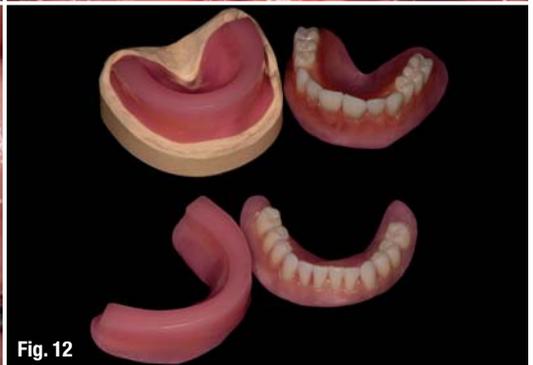
Fig. 12

Fig. 12_The initial diagnostic set-up must be adapted to the altered mucosal contour.

The canines are supplied with root posts. The original diagnostic setup is adapted to the altered soft tissue structure. The prosthetic restoration is shown in part in Figures 12 to 14. You can follow the detailed procedure online, documented with numerous images.

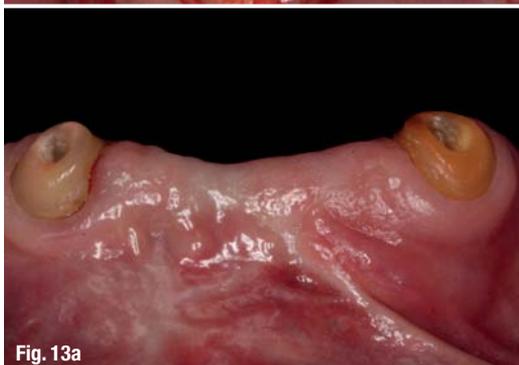
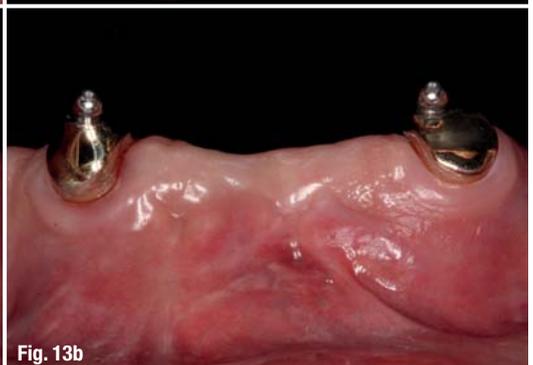
Fig. 13a

Figs. 13a & b_Cementation of root caps.

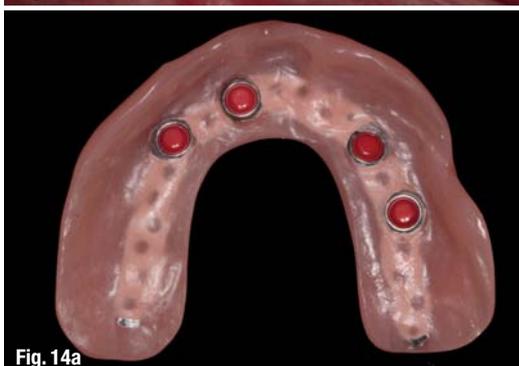
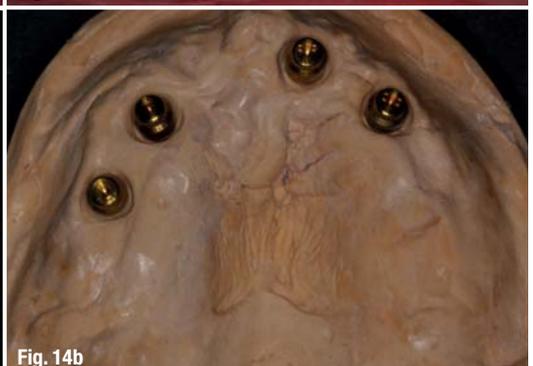
Fig. 14a

Figs. 14a & b_Final maxillary prostheses.

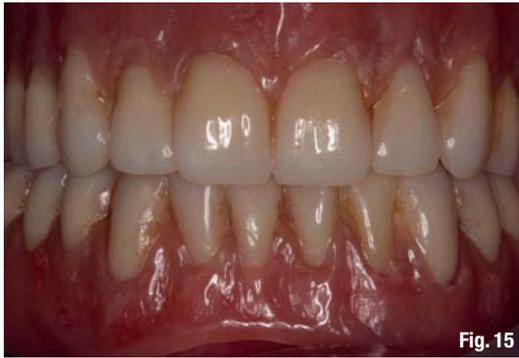
Fig. 15

Fig. 15_Final clinical results.
Fig. 16_Final radiological findings.
Figs. 17a & b_Clinical situation before and after therapy: optimised tooth alignment and smile line.

The patient adapted well to the new prosthesis. He was pleased with the stability and aesthetic appearance (Figs. 15–17).
