# Laser Supported Treatment of Periimplantitis on a Strategically Important Individual Tooth Implant in the Superior Maxilla

author\_Georg Bach, Germany

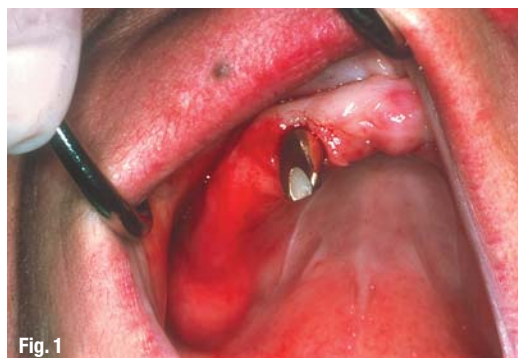
**Fig. 1** Regio 13, an ITI implant has been incorporated onto which a primary crown was mounted. A mucositis manifested itself that could already be clinically diagnosed.

In 1991, the 43-year-old female patient had an ITI implant incorporated alio loco regio 13 (Fig. 1). Except for the remaining tooth 23, the superior maxilla is edentulous. After the healing-in process of the implant, a telescopic crown was placed onto the implant and the remaining tooth 23, onto which a telescopic prosthesis is fastened (Figs. 3, 4). After completion of the prosthetic phase, no recall took place because the patient moved away. Upon the recommendation of an acquaintance, the patient came back to our office in

1994 when she detected that brushing implant abutment 13 resulted in profuse bleeding. The clinical findings verified this observation. Probing with a pressure-calibrated plastic PA probe, BOP could be found and also there was a circular probing depth of 6 mm.

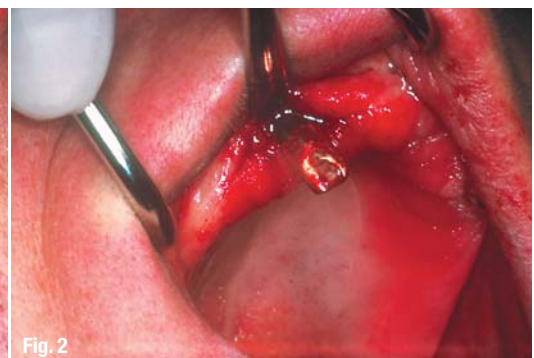
**Fig. 2** Formation of a mucoperiosteal flap at the implant.

After extensive information from the patient and application of local anesthesia, a mucoperiosteal flap was opened up at the implant (Fig. 2). The granulation tissue was thoroughly removed by means of plastic curettes, and the edges of the flap were thinned out. The overall extent of bone loss attachment then became evident as the bone crater typical for periimplantitis was found.

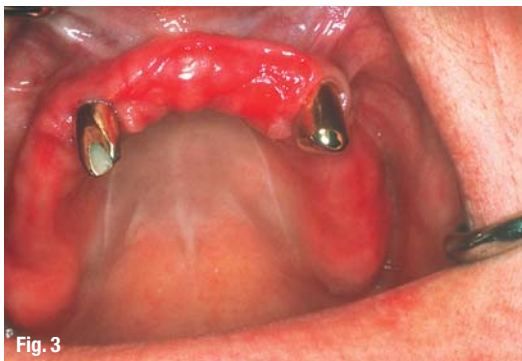
**Fig. 3** Six-months postoperative check; please note the irritation-free wound condition.

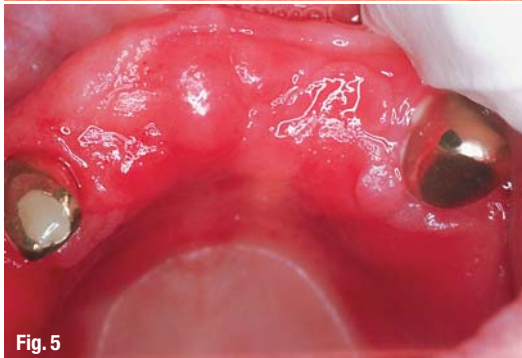
**Fig. 5** More than ten years after the completion of the surgical resective phase, both abutments are still in the superior maxilla.

each other in a flushing manner to ensure healing per primam intentionem. The suture material was removed after one week. Further recall sittings took place after 6 weeks and 3 months. At the final inspection of the surgical resective phase after 6 months, the former surgical area was without irritation (Fig. 5). No probing depth could be measured. The telescopic superior maxilla prosthesis is in situ without irritation (Fig. 6).

Now, more than ten years after the surgical treatment of the periimplantary lesion, the prosthetic situation in the superior maxilla is unchanged. The telescopic bridge is still in place on 13 (supported by the implant) and 23 (natural tooth) (Fig. 5). The ITI implant regio 13 is located in a healthy environment without irritation, and, even after removal of the secondary crown, healthy periimplantary conditions are found (Fig. 7).

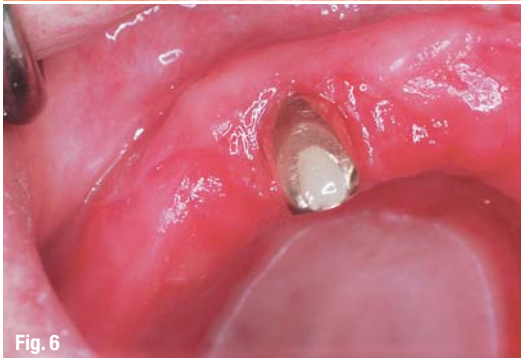
**Fig. 6** The individual implant regio 13 is in an irritation-free environment.

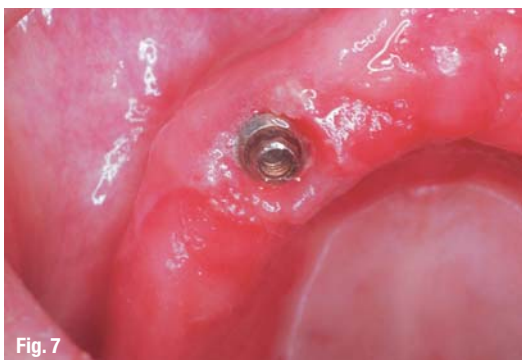
**Fig. 7** Even after removal of the secondary crown, healthy periimplantary conditions are found.

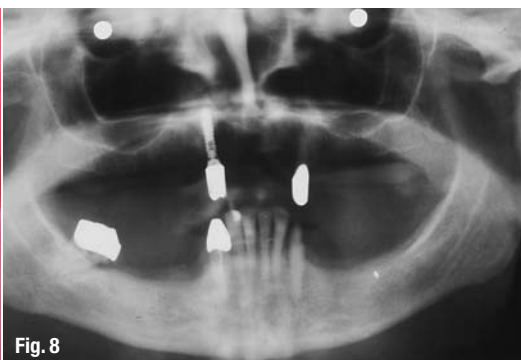
**Fig. 8** X-ray (OPT) 1994.

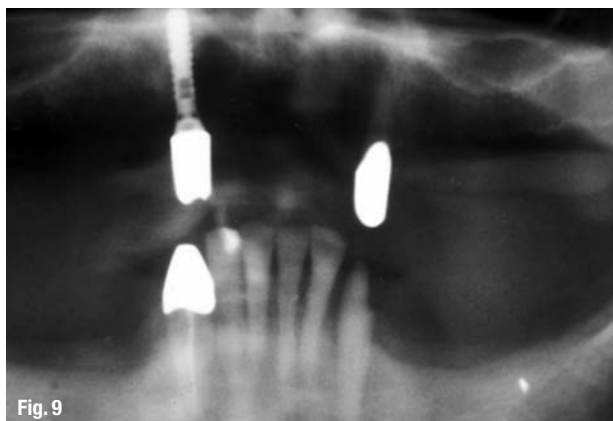
Fig. 9

**Fig. 9**\_Detail from X-ray 1994: Typical bone lesion, cause by periimplantitis.

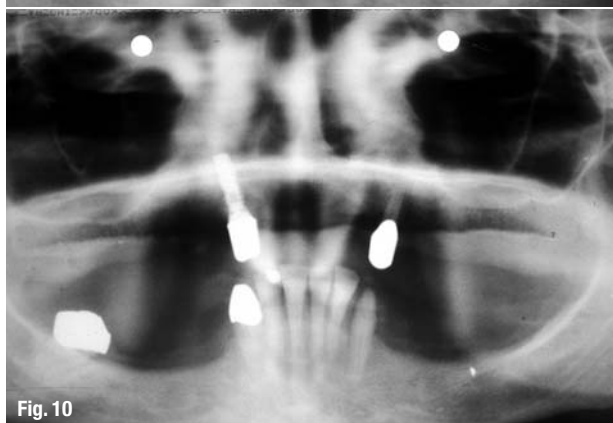
Fig. 10

**Fig. 10**\_No progressive bone loss at the implant (region 13) can be seen.
