## Oral rehabilitation in the aesthetic area—One-year follow-up

# Immediate ceramic implant with immediate provisionalisation and connective tissue graft

This case report aimed to describe the step-by-step oral rehabilitation using immediate implant with immediate provisionalisation using ceramic implants and connective tissue grafts and its clinical and radiographic performance after a 12-month follow-up period in the aesthetic area (lateral upper incisor).

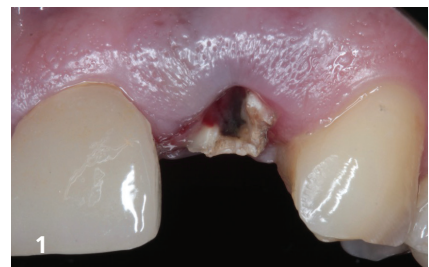
Fig. 1: Initial clinical situation.

The patient is male, 54 years old, healthy, and had suffered a fall from his own height in the past, in which the upper left lateral incisor was broken. On clinical examination (Fig. 1), a root fracture was found at the subgingival level and apparently infra-osseous, later confirmed through imaging tests (CBCT and peria-

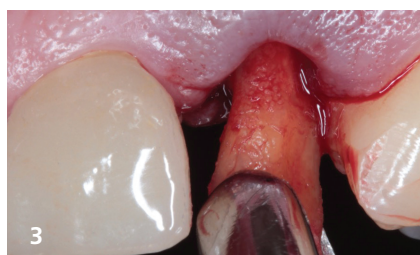
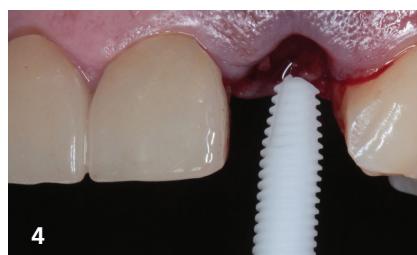
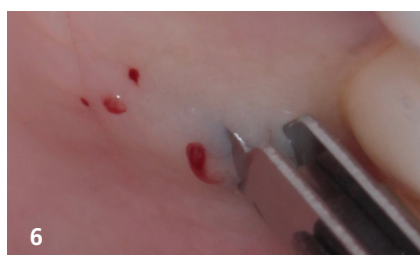
**Fig. 3:** Elevation of the tooth from inside the socket. **Fig. 4:** Neodent Zi implant 3.75x13 mm. **Fig. 5:** Occlusal view of the fresh socket—Zi-lock connection. **Fig. 6:** Removing the connective tissue graft with the double blade technique. **Fig. 7:** Connective tissue graft positioned on the vestibular side of the fresh socket. **Fig. 8:** CR abutment and connective tissue fixed with blue nylon suture. **Fig. 9:** Occlusal view of the CR abutment with gap filling with bone substitute.

The patient was instructed to perform antibiotic prophylaxis with four tablets of Amoxicillin 500 mg one hour beforehand and rinsed the mouth with 0.12% chlorhexidine for 30 seconds before receiving local anaesthesia with 4% Articaine (1:100,000 epinephrine). Then, the extraction was performed atraumatically with the aid of manual periostomes and forceps (Fig. 3) and a two-piece ceramic implant (Neodent Zi Ceramic Implant®, 3.75 x 13.0 mm) was placed in the fresh alveolus (Fig. 4). The Insertion torque was 35 Ncm. It should be noted that the in-

30rpm with 35Ncm of torque, at the level of the bone crest (Fig. 5).

On the vestibular area, a CTG was removed from the patient's own palate using the DBT (Fig. 6) and fixed with Blue Nylon 6/0 suture (Techsuture; Figs. 7 & 8). To fill the "gap" between the external wall of the implant and the internal surface of the buccal wall of the alveoli, a bone substitute was used (Straumann® maxresorb® 0.5–1.0mm, 0.5cc; Fig. 9). A 4.5x5.0x1.5mm (regular) zirconia abutment (CR Zi Pillar®) was installed (Figs. 10a & b). Finally, a provisional restoration was made with light-cured composite resin and cemented on the ceramic abutment (Fig. 11).

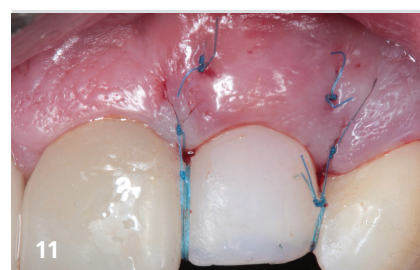
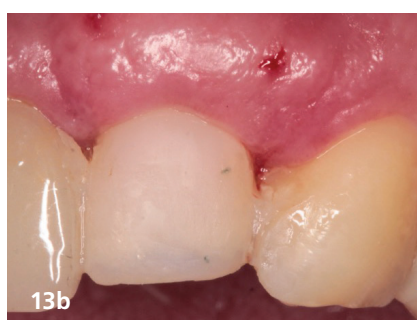
**Figs. 10a & b:** Temporary crown made of light-cured resin. **Fig. 11:** Temporary crown positioned and sutured. **Fig. 12:** Immediate postoperative radiographic image. **Figs. 13a & b:** 14 days postoperative—suture removal.

At the end of the surgical procedure, a periapical X-ray was taken (Fig. 12). The Patient returned 14 days later for suture removal (Figs. 13a & b) and received the necessary instructions. The four-month postoperative period was uneventful, and after this period, the patient returned in order to begin the prosthetic rehabilitation phase.

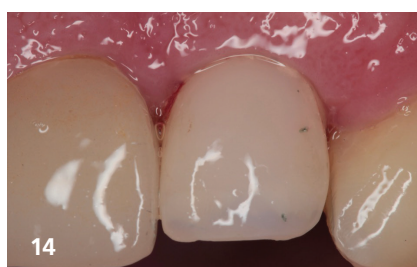
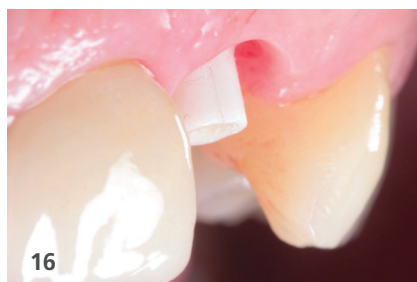
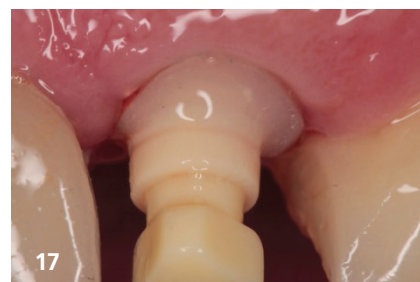
**Fig. 14:** Four months of follow-up. **Fig. 15:** Peri-implant tissue with a healthy appearance (occlusal view). **Fig. 16:** Peri-implant tissue with a healthy appearance (lateral view). **Fig. 17:** Closed impression technique with flow resin to copy the gingival emergence profile and addition silicone (Yllér).

After four months (Figs. 14–16), the patient returned to have the definitive crown made. This crown was fabricated using the analogic with a conventional impression that was taken with addition silicone with putty and regular body (Yllcr; Fig. 17), using the closed tray technique. One lithium disilicate crown (e.max®) was manufactured and cemented with adhesive cement (RelyX™ U200, 3M) onto the prosthetic abutments (Figs. 18 & 19). Occlusal adjustments were performed. At the end of the treatment, a final periapical X-ray was taken, and it was possible to observe the bone stability and the adaptation of the prosthetic work (Fig. 20).

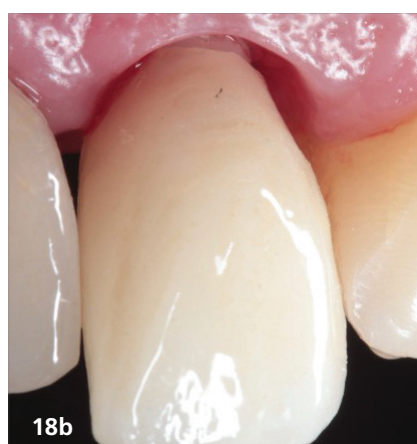
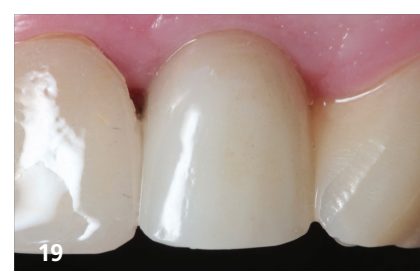
**Figs. 18a & b:** e.max crown being positioned over the CR abutment with maintenance of interdental papillae and peri-implant volume. **Fig. 19:** e.max crown cemented. **Fig. 20:** 12-month follow-up X-ray. **Fig. 21:** Visual analogue scale.

After 12 months, the patient was asked to return and a new X-ray was taken,

showing the stability of the alveolar bone crest without marginal bone loss (MBL).
