# Metal-free rehabilitation with bioactive glass-ceramic implants

Dr Saurabh Gupta, India

This case report describes the comprehensive rehabilitation of a female patient in her thirties with longstanding food-related allergy-like symptoms and chronic gastrointestinal manifestations who requested complete metal-free dental treatment. The treatment included orthodontic aligner correction to establish functional occlusion, atraumatic removal of a failing titanium implant, extraction of a compromised root canal-treated tooth, placement of two zirconia dental implants, and definitive zirconia restorations. Healing was uneventful, with excellent aesthetic and functional outcomes. During follow-up, the patient reported a marked improvement in her overall well-being, including significant reduction in food-related allergy-like symptoms and chronic skin manifestations. Although these observations represent patient-reported outcomes and do not establish causality, this case demonstrates the successful application of comprehensive biological rehabilitation using bioactive glass ceramic implants and highlights the importance of documenting patient-centered outcomes.

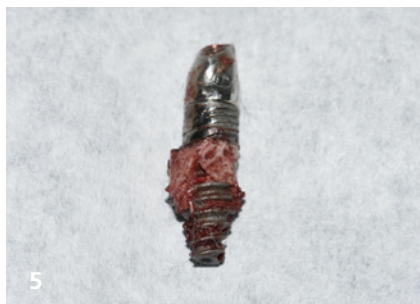
**Fig. 5:** Removal of the titanium implant using a trephine drill. – **Fig. 6:** Meridian® implants planned for sites #11 and #21.

After approximately six weeks, the existing titanium implant at tooth #21 was removed under local anaesthesia using a trephine bur with careful preservation of the surrounding alveolar bone. Manual debridement was done followed by dis-

infection with Ozone DTA using plasma probes. Another monobloc zirconia implant was immediately placed into the prepared site, achieving satisfactory primary

stability. No bone grafting procedures were required, and healing was allowed to proceed under a minimally invasive protocol (Figs. 5+6).

After approximately six weeks, the existing titanium implant at site #21 was removed under local anesthesia using a trephine bur, with careful preservation of the surrounding alveolar bone. The site was manually debrided and disinfected using Ozone DTA with plasma probes. A monobloc zirconia implant was then immediately placed into the prepared site, achieving excellent primary stability. No bone grafting was required, and healing proceeded according to a minimally invasive protocol (Figs. 5+6).

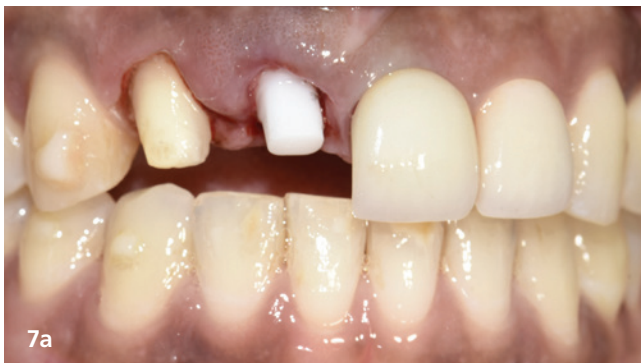
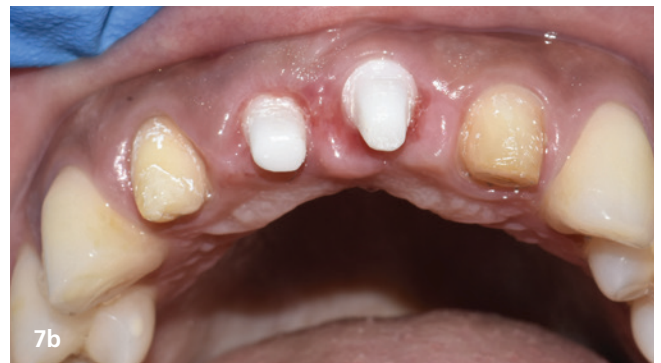
At the site of tooth #21, following removal of the titanium implant, mild loss of the crestal bone and a corresponding reduction in the gingival height were observed. The resulting soft-tissue deficiency led to a slight compromise in the gingival architecture compared with the contralateral side.

**Figs. 7a+b:** Implant placement in phase 1 at site #11 and phase 2 at site #21. –

The patient was thoroughly informed about the available treatment options, including soft-tissue augmentation (connective tissue grafting) and hard-tissue augmentation to improve the peri-implant tissue contours. However, she declined all grafting procedures, preferring to avoid additional surgical interventions (Figs. 7a+b).

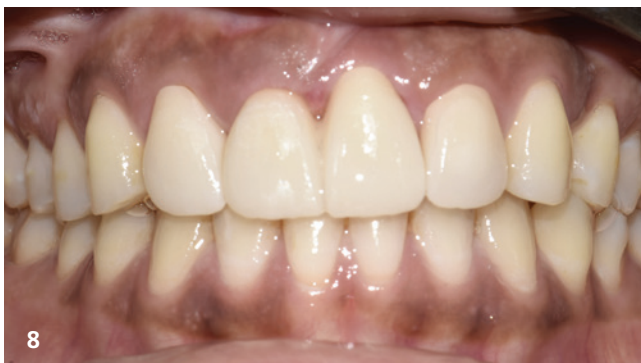
**Fig. 8:** Final zirconia restorations on teeth #12, #11, #21, and #22.

Four zirconia crowns (Fx, Amman Girschbach) were fabricated to restore teeth #11, #12, #21, and #22, creating a completely metal-free anterior rehabilitation.
