# Immediately placed two-piece zirconia implant with customised healing abutment in the maxillary molar region

Drs Alexandre Marques Paes da Silva, Dennis de Carvalho Ferreira, Francisco Augusto Horta dos Santos, Mayla Kezy Silva Teixeira, Daniel Moraes Telles & Eduardo José Veras Lourenço, Brazil

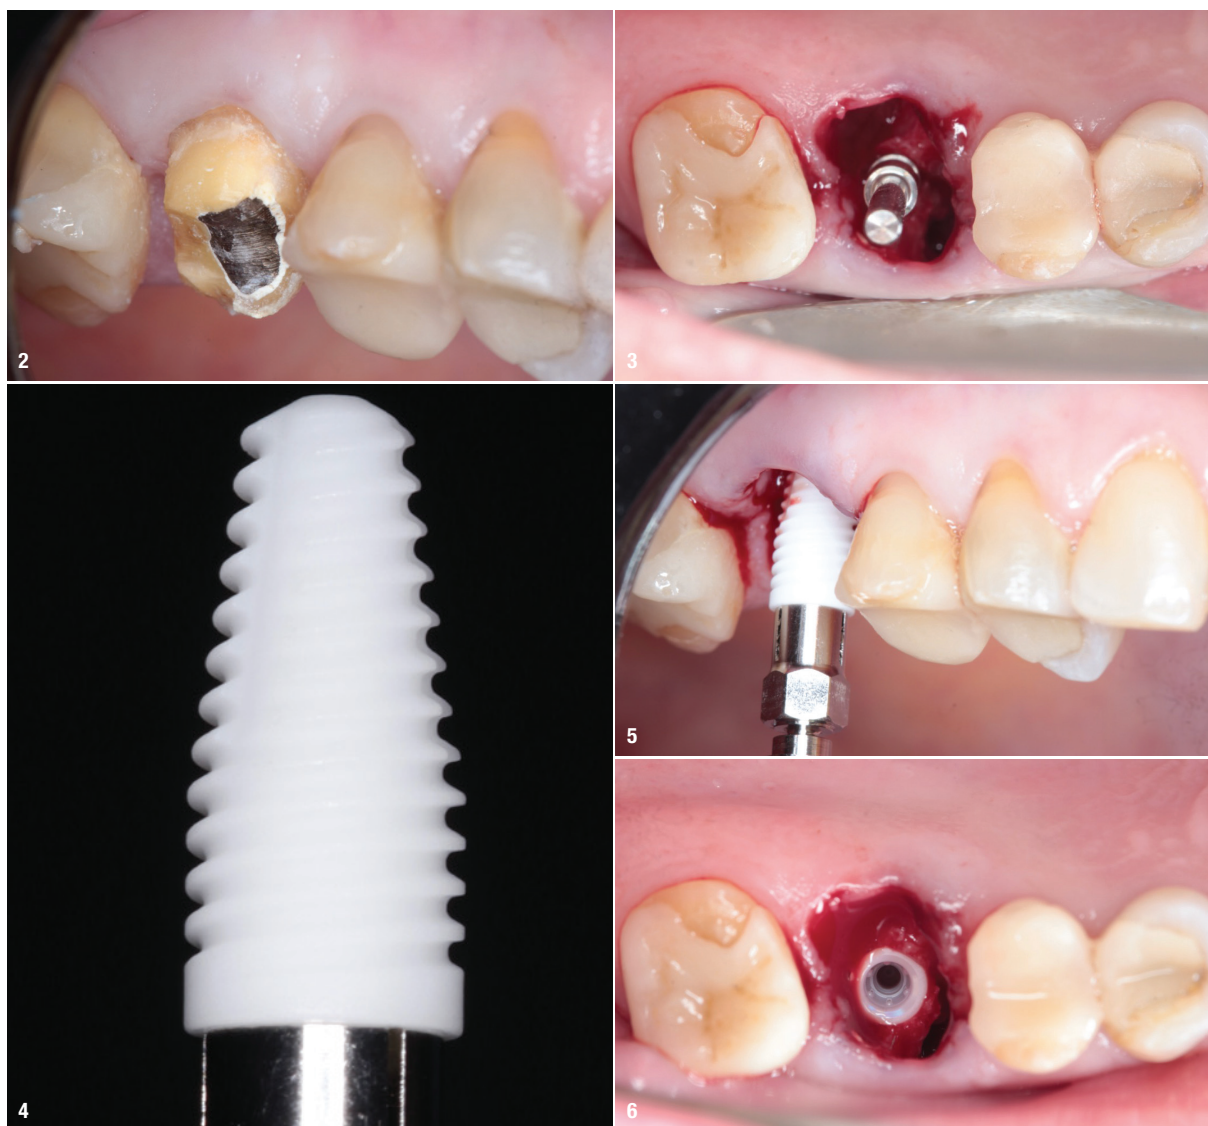
**Fig. 2:** Pre-op situation before sectioning of the roots. **Fig. 3:** Socket preparation. **Fig. 4:** GZi implant. **Fig. 5:** Placement of the implant **Fig. 6:** Final bone-level position of the implant.

After local anaesthesia (4% articaine with 1:100,000 adrenaline, DFL), tooth extraction was performed via a minimally invasive surgical approach. The roots of the first molar were sectioned and extracted separately using delicate periostomes to sever the periodontal ligament and lift the tooth pieces without flap raising (Fig. 2). After

extraction, the alveolus was thoroughly curetted to remove any inflammatory tissue and abundantly irrigated with saline solution. The recipient site preparation sequence was performed according to the manufacturer's recommendations (Zi ceramic implant, Neodent) as described in a previous study (Fig. 3).<sup>13</sup> A two-piece yttria-stabilised zirconia implant (4.3 × 10.0 mm) was placed into the socket to a final insertion torque of 45 Ncm (Figs. 4–6).

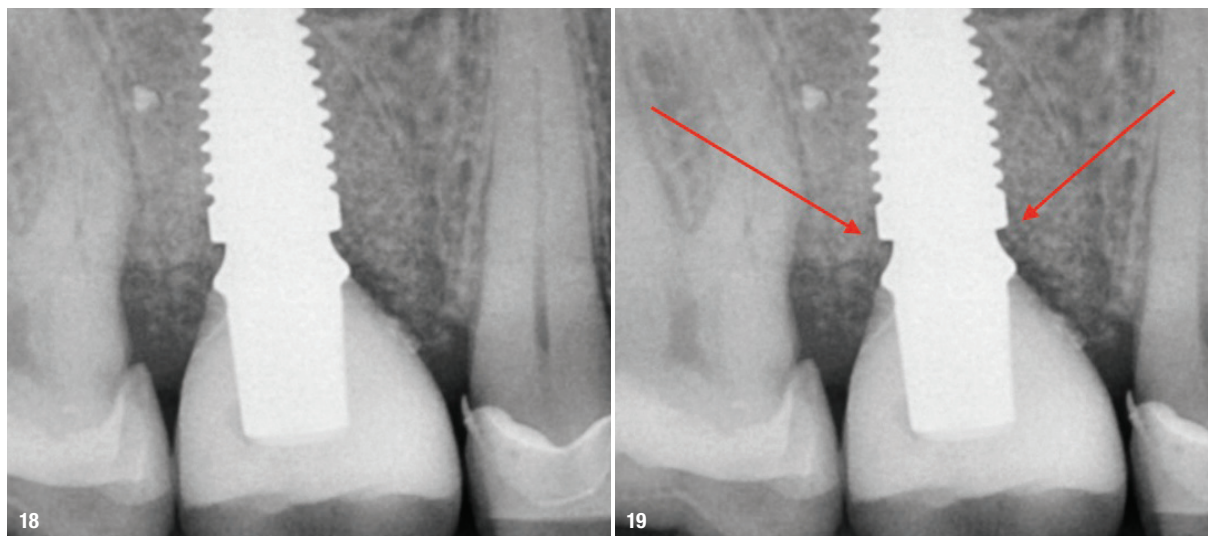
**Fig. 18:** Final radiograph with the definitive crown. **Fig. 19:** Radiograph at ten months showing marginal bone stability.

After cementation of the definitive crown, the stability of the marginal bone level was observed on the final radiograph in relation to the immediate postoperative radiograph. The patient has been followed up periodically for the last ten months, and there have been no complications to date. At the end of the treatment, she was asked to rate her degree of satisfaction with the aesthetic results of the treatment according a visual analogue scale and selected "very satisfied".
