# One-piece AWI G-Line ceramic implants in the premolar region

# Clinical use of the AWI single-unit implant system following delayed implantation

Bozhidar Hristov Savev, Germany

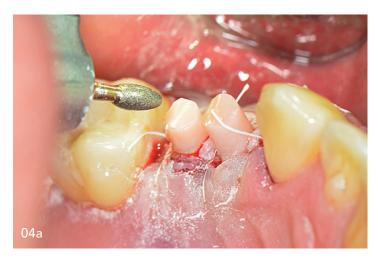
The patient requested a fully metal-free solution, including the prosthetic restoration. Six months later, the alveolar ridge was assessed as suitable for implant placement (CBCT and clinical pre-op: Figs. 2a+b). A crestal incision with a releasing cut at tooth 13 was made, and a mucoperiosteal flap was elevated (Fig. 2c). Two one-piece AWI G-Line zirconia implants (AWI 394010R, gingiva-coloured) were inserted (Figs. 3a–h).

Simultaneous lateral augmentation was carried out using β-TCP Easy Graft and PRGF membranes to cover both the graft and the implants, enhancing wound healing. A post-operative radiograph confirmed correct implant placement (Fig. 4c).

Therefore, ceramic implants must be inserted at a slower rotational speed to avoid excessive interface temperatures. Post-insertion, the implants were shortened and shaped using a red contra-angle handpiece and ceramic polishing instruments (Figs. 4a+b). Healing was performed transgingivally over four to six months.

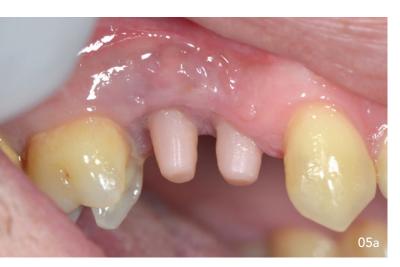
Figures 5b and c show well-healed soft tissue around the implant sites. If necessary, the implant shoulder can be positioned 1.5–2 mm subgingivally in a scalloped fashion to match the natural gingival architecture.

In the same appointment, tooth 16 was prepared for a partial crown. A conventional impression was taken using Honigum Heavy and Light materials (DMG). Final restoration was performed using pressed monolithic e.max crowns. The final result in the upper jaw is shown in Figures 5c and d.
