# Natural preservation of the emergence profile

**Authors:** Dr Umut Baysal & Dr Arzu Tuna, Germany

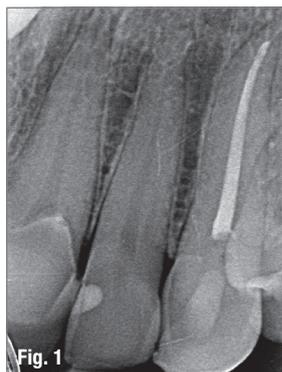
**Fig. 1:** Initial condition of tooth 23 on single-tooth radiograph.

The labial surface in the medium third of the root of tooth 23 was very sensitive to percussion. A dental X-ray scan of region 21–24 did not show any signs of resorptive processes (Fig. 1). The therapeutic goal was to restore the proper function of tooth 23 and to remediate the inflammatory processes. We suggested various therapeutic options and chose the implantological treatment.

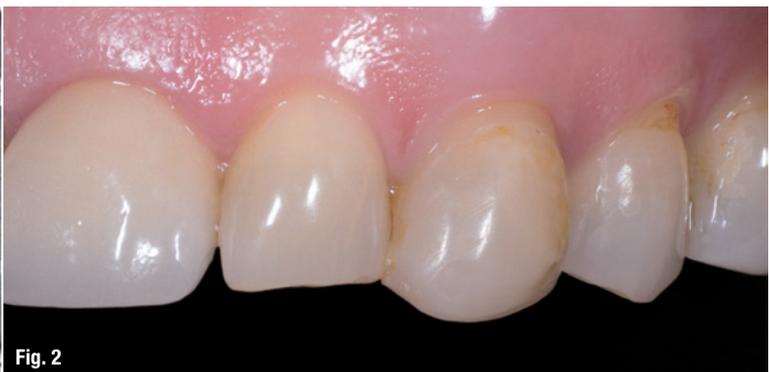
**Fig. 2:** Intraoral initial condition of tooth 23.

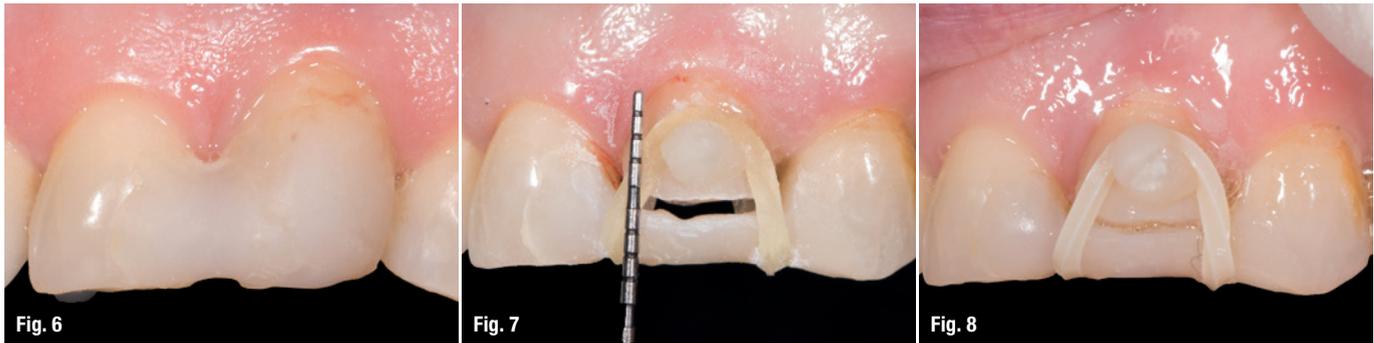
**Fig. 6:** After ten days already, a loss of marginal gingiva of about 1 mm in apical direction is evident.

**Fig. 7:** Condition prior to extrusion by means of rubber bands over a period of 24 hours.

**Fig. 8:** Condition after 24 hours. The reactive tissue in the marginal area is very nicely shown. The soft tissue is the first to follow the traction, then the bone.

After ten days, a loss of approximately 1 mm of marginal gingiva in apical direction became evident (Fig. 6). We intended to recapture that by means of extrusion. The replanted crown was separated in the upper third (Fig. 7) after a healing time of ten days and extruded by 1 mm using rubber bands for 24 hours (Fig. 8). You can see the reactive tissue in the marginal area very nicely. The soft tissue is the first to follow the traction, then the bone. The stabilisation phase until the implantation was 16 weeks.

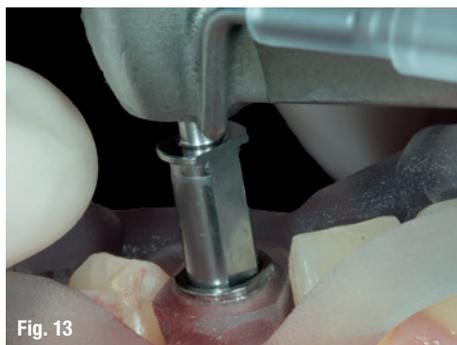
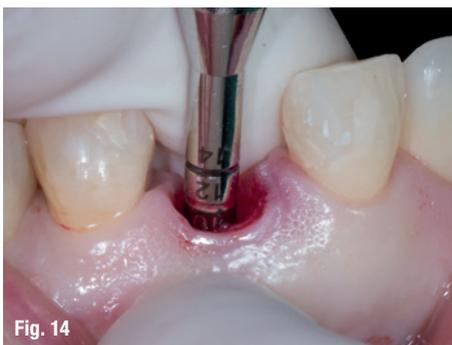
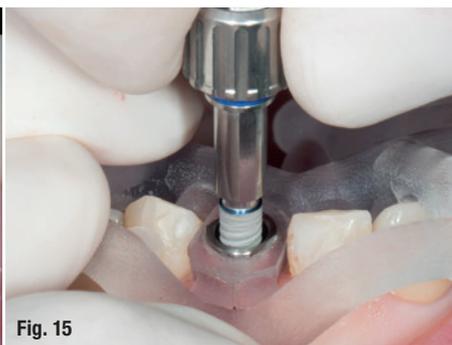
**Fig. 13:** Template-guided pilot hole (MIS Guide).

**Fig. 14:** After the pilot hole, the implant bed was further prepared, exclusively with osteotomes.

**Fig. 15:** A 3.3/11.5 mm implant in a special triangular design of the crest, which increases the bone deposit in the critical zone additionally used (V3, MIS Implants).

palatal direction with sufficient osseous volume of 2 mm on the buccal side. The replanted crown makes it possible to plan the implant position allowing for the prosthetic component in terms of backward planning. A template-guided implantation facilitates the incision-free technique and shorter treatment period, reduced patient morbidity, and better surface texture of the soft tissue. Figure 11 shows the situation after removal of the replanted crown and prior to the implantation. Using a micro scalpel blade, access to the bone was established (Fig. 12). Afterwards, the pilot hole was drilled using the template (MIS Guide, Fig. 13) and the further preparation performed with osteotomes (Fig. 14) after inspection of the buccal bone lamella. Despite the preventive measures, the purely subtractive preparation of the implant bed using drills was not indicated. We used a 3.3/11.5 mm implant in a special triangular design of the crest, which increases the bone deposit in the critical zone additionally (V3, MIS; Figs. 15 and 16).

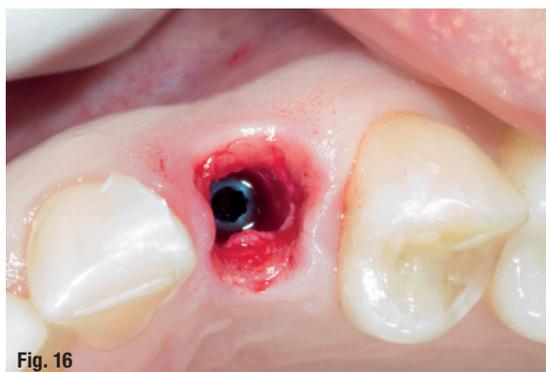
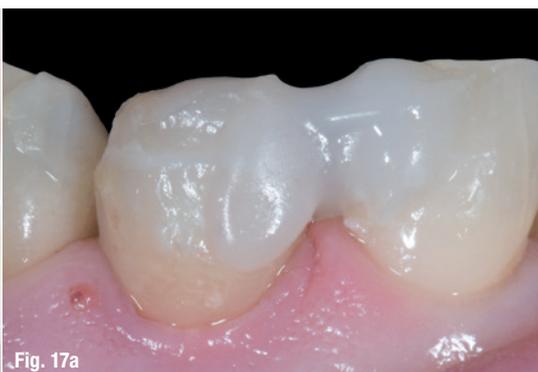
**Fig. 16:** Condition after implantation and prior to replantation of dental crown. The atraumatic status and the complete preservation of the emergence profile are remarkable.

**Fig. 17a:** Condition right after implantation.

**Fig. 17b:** Single-tooth radiograph after implantation.

After the implantation, the crown was replanted. Figures 16a und 17a show the status of the soft tissue right after the implantation. The atraumatic status and the complete preservation of the emergence profile are remarkable. A single-tooth radiograph was prepared to check the implantation (Fig. 17b).

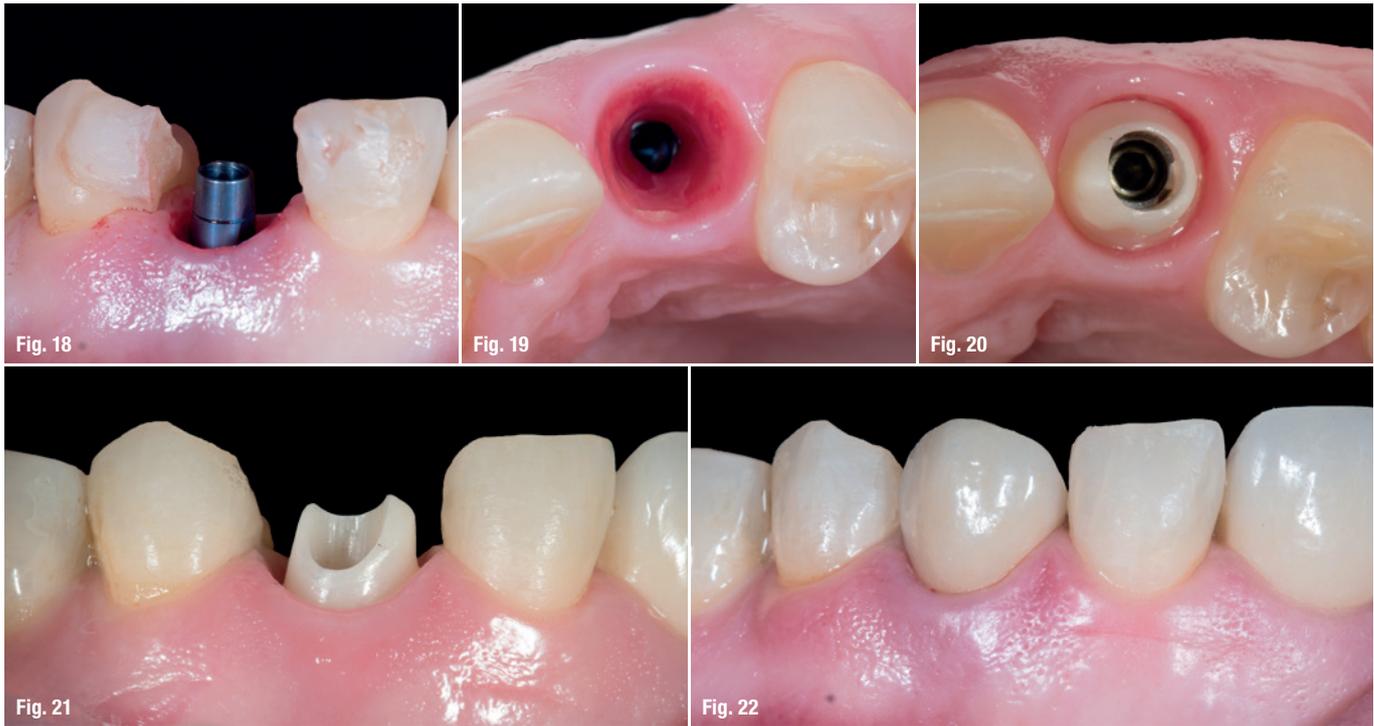
**Fig. 18:** Condition after exposure and prior to dental impression.

**Fig. 19:** To try the definite abutment on, the composite residues were removed from the adjacent teeth.

**Fig. 20:** The abutment was fixed tightly using a new screw according to the manufacturer's instructions.

A new silicone impression was made in filament technique. This impression serves to manufacture the crown with the newly defined contact points to the adjacent teeth.

**Fig. 21:** Buccal view.

**Fig. 22:** Condition right after placement of crown.

The dental impressions were taken in an analogue procedure using a closed tray via a transfer cap (Fig. 18). The next step was the manufacture of an individual hybrid abutment (titanium adhesive bonding, zircon abutment) at the laboratory. A digital dental impression would have the advantage that data scanned before the tooth extraction could be matched with the impression after exposure, thus enabling an exact copy of the natural tooth in line with the "biogeneric copy" concept.<sup>10</sup> In the present case, we abstained from the digital workflow because the crown was individually manufactured in laminated ceramics. The dental crown was replanted again after the impression was taken.

In the next session, the definite abutment (Fig. 19) and a synthetic crown were tried on for aesthetic analysis. We removed the composite residues from the adjacent teeth and fixed the abutment tightly using a new screw according to the manufacturer's instructions (Fig. 20). A new silicone impression was made in filament technique. This impression serves to manufacture of the crown with the newly defined contact points to the adjacent teeth. Previously, the laboratory had manufactured an analogue to the abutment of super-hard plaster to ensure the exact preparation of the crown margin. Figure 21 shows the abutment after removal of the composite residues from the adjacent teeth. The synthetic crown was fixed using provisional cement (Telio CS Link, Ivoclar Vivadent). We were thus able to abstain from another replantation of the dental crown. The synthetic crown provides us with diagnostic value with regard to the

final appearance of the peri-implant soft tissue and the form of the crown.<sup>12</sup> Additional optimisation by applying and removing provisional masses to form the emergence is not necessary anymore in most cases. This shortens the treatment duration considerably. Figure 22 shows the definite crown right after its placement (Variolink Esthetic DC, Ivoclar Vivadent).
