# Peri-implantitis therapy

## Using resorbable bone replacement material

Dr Fernando Duarte, Portugal & Dr Gregor Thomas, Germany

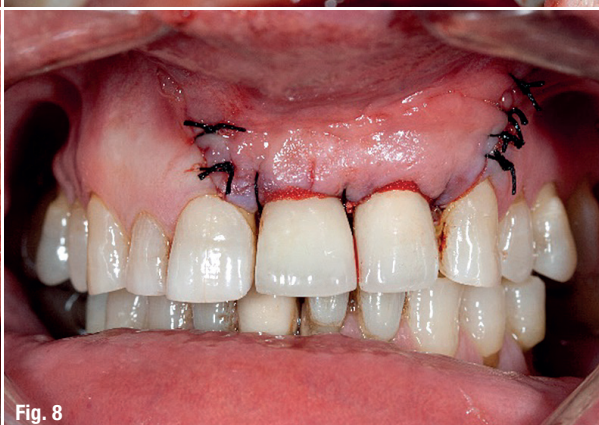
Fig. 8

Finally, the surgical area was covered with the bioresorbable membrane, and the flap was re-adapted with interrupted sutures in order to achieve a complete and impermeable wound closure (Fig. 8). The radiograph taken immediately after surgery showed the filled defect
