Successful immediate implant loading—According to the **Socket Shield** Technique

Dr Ramón Gómez Meda, Spain

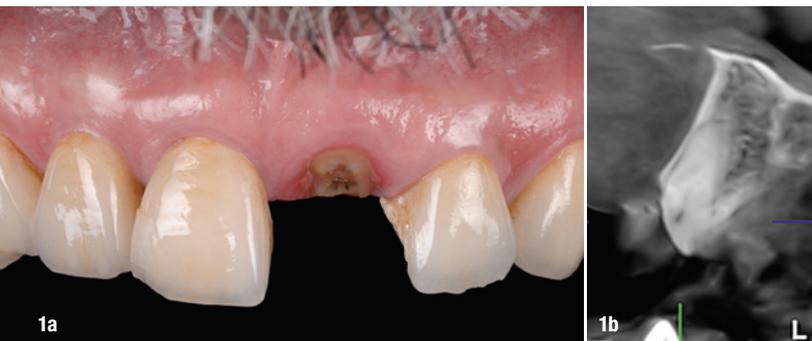
Figs. 1a & b: Initial situation before partial extraction of the fractured tooth and immediate implant placement. The epigingival fracture made a horizontal reduction of the root unnecessary.

splinted but even so the crown of the tooth broke horizontally at gingival level. The pulp sensitivity test of the fractured tooth with CO₂ snow was negative, the peri-coronal tissue was irritated, but showed absence of active purulent infections. Hard and soft tissue showed no signs of bone loss or recession, in comparison of the soft tissue and bone support of the two maxillary quadrants there was no difference from one quadrant to the other. Radiologically the root remnant showed no alterations or signs of fracture (Figs. 1a & b). Oral hygiene was good. Tooth conservation was assessed to be feasible but seemed rather unpredictable due to the

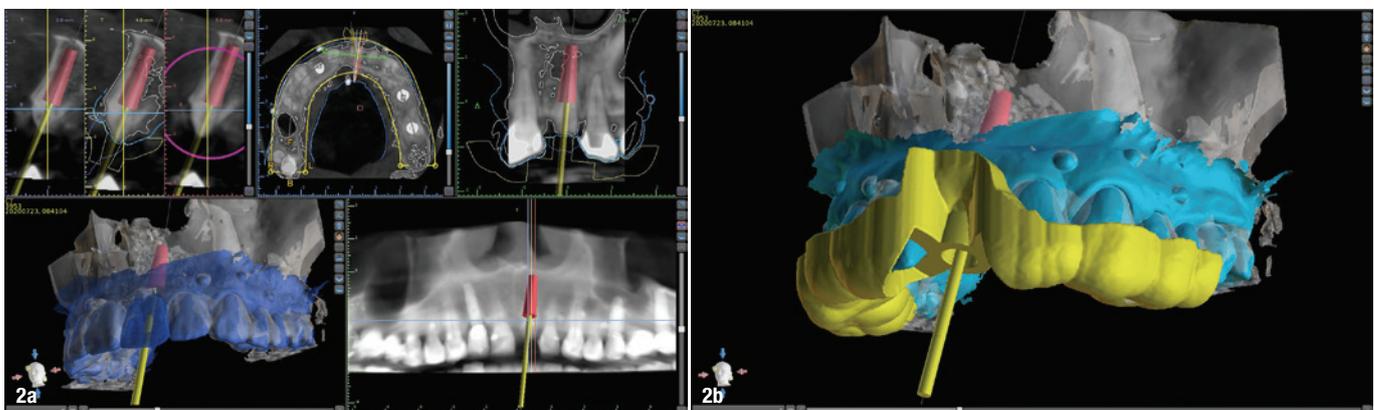
Figs. 2a & b: The DICOM files as well as the intra-oral STL files were imported into a software (Blue Sky Bio) to plan the ideal implant position. Finally, a surgical guide was printed.

(Planmeca Promax 3D Plus) paying special attention to the integrity of the cortical plate and the quantity of bone present in the apical area to be able to properly stabilise the implant. The DICOM files as well as the intra-oral STL files were imported into a software (Blue Sky Bio). These files were superimposed and a virtual wax-up helped to create the exact virtual position of the implant with an ideal prosthodontic emergence profile. Finally, a surgical guide was designed and immediately printed at the office with the help of a high-quality 3D printer (Nextdent 5100, 3D Systems; Figs. 2a & b). An alginate impression was taken to elaborate a thermoplastic vacuum formed provisional and the patient was released with a crown integrated into the removable template to temporarily solve the aesthetic problem. Antibiotics and AINES were prescribed for the day of the surgery. Also, the patient was advised to rinse his teeth with an antiseptic solution (0.2% chlorhexidine, DENTAID) the day before the surgery to reduce the bacteria load in the mouth. The crown of the fractured tooth (Fig. 3) was handed to the dental technician for orientation to build the screw-fixed temporary restoration on the implant for day of surgery.

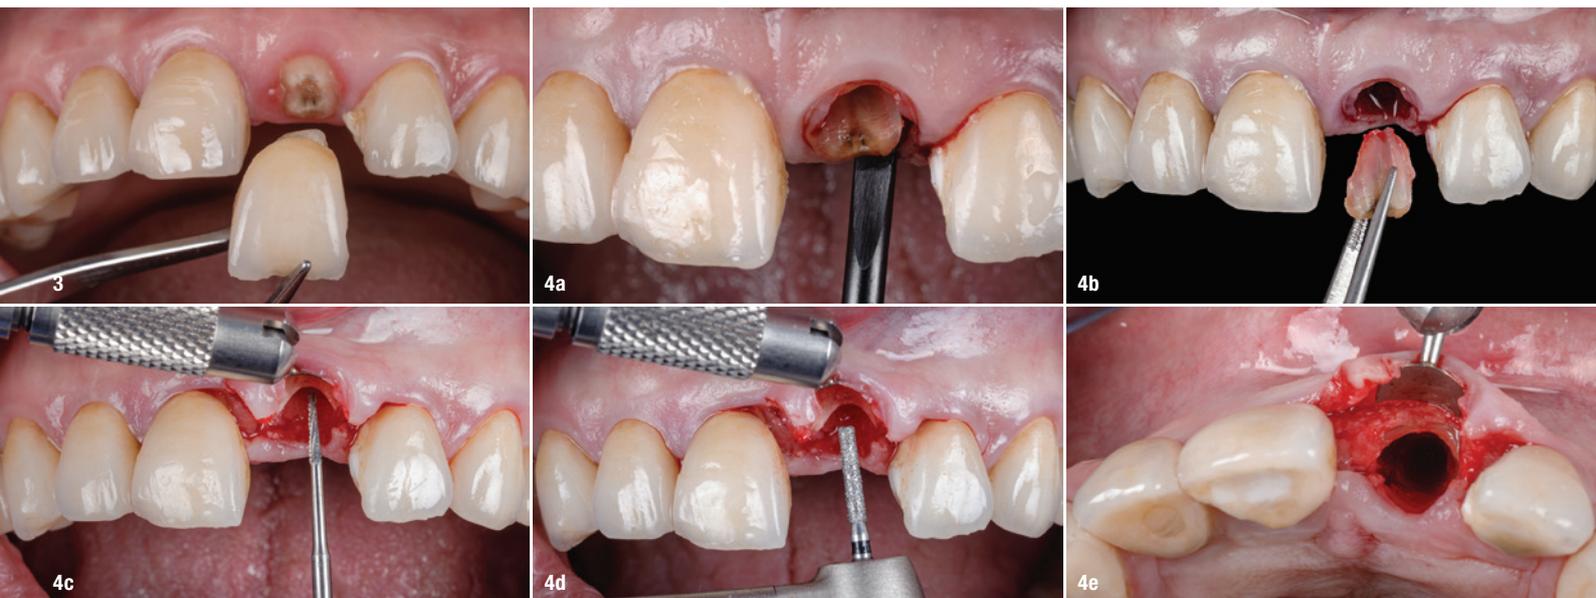
Fig. 3: After impression taking, the fractured crown was sent to the laboratory technician to copy the shape and colour. **Figs. 4a–e:** Partial tooth extraction with Socket Shield approach: bisection of the root, extraction of the palatal parts and contouring of the buccal shield.

was mobilised in order to better control later tooth fragment preparation and the surrounding tissue. Before implant bed preparation, the root was bisected vertically and the palatal aspect of the root was removed (Figs. 4a–e). Further dentine parts were removed in individual pieces, focusing to extract the entire root tip. The guide template was seated to prepare the implant bed through the root remnants. Sterile saline coolant was used during the entire drilling procedure. Only a small part of the root in the crestal area on the buccal side was intentionally left in place preserving the facial part of the periodontal ligament and as a consequence the bundle bone (Fig. 4e). As accurate tooth fragment preparation and implant placement is the key to successful treatment with the Socket Shield Technique,⁶ the buccal root piece needed a little reshape with a lancet drill to thin it and such to guarantee that the dentine would not be in direct contact with the implant for proper bone formation.

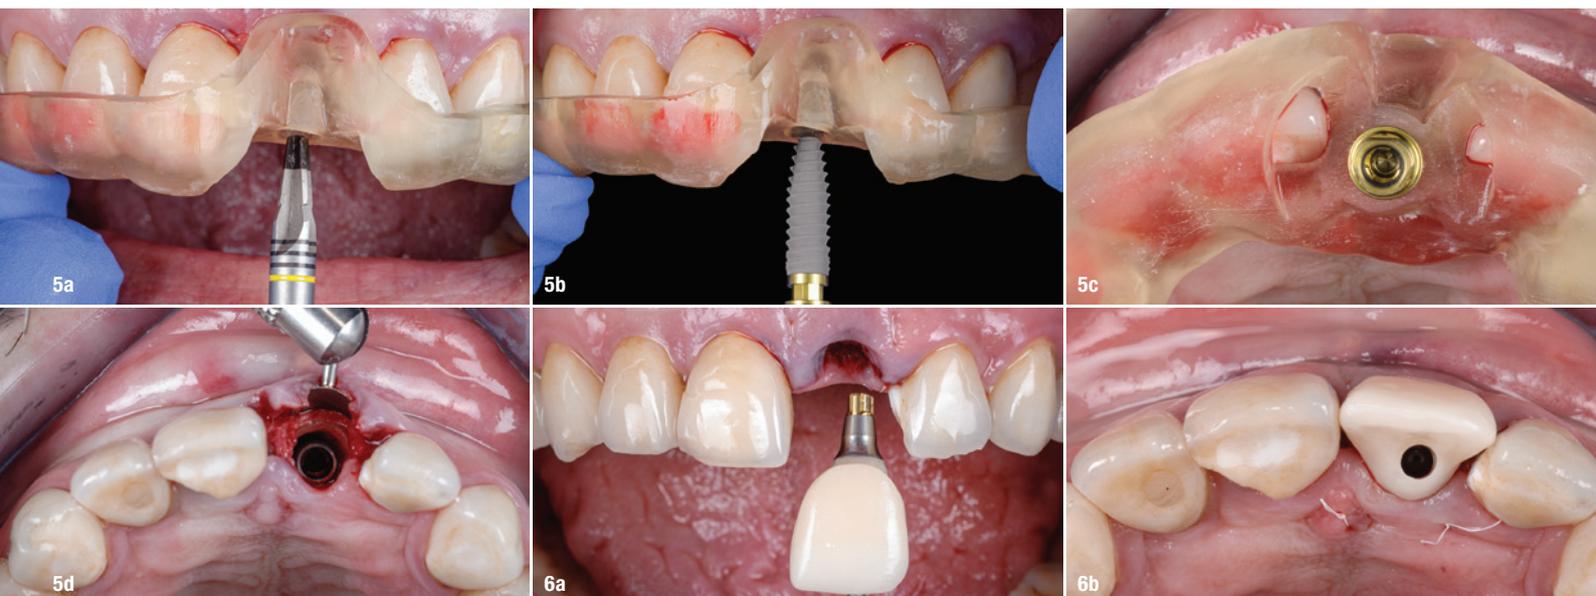
Figs. 5a–d: Fully guided placement of the implant into the exact 3D prosthodontic position, in distance to the root shield. Care was given to not change the position of the buccal root shield. **Figs. 6a & b:** The interim restoration had been designed based on the intra-oral scan. It could be screwed onto the implant immediately after the surgery to close the extraction wound and preserve the soft tissue.

A PROGRESSIVE-LINE (CONOLOG 3.8x13mm) implant was placed fully guided in the palatal part of the extraction socket in the correct 3D prosthodontic position (Figs. 5a–d). As being an apically tapered implant and threads down to the apex, this implant was chosen for the surgery as it enables to anchorage well within the basal bone but still not endangering the buccal lamella in the apical area. Also, the pronounced thread design makes it easy to reach very good primary stability even in situations with poor quality bone. Reaching an insertion torque of more than 35Ncm, the implant qualified to be restored immediately with a screw-

retained one-piece provisional crown (Figs. 6a & b). Therefore, a scan body had been screwed in immediately after implant placement to register the 3D position of the implant and scanned digitally (Figs. 7a & b). The interim restoration was designed in the office after importing the STL file into a professional software (Exocad dentalCAD) and after half an hour the provisional was manufactured with a milling machine (Ceramill Motion 2 5X, Amann Girrbach). Afterwards the wound was microsurgically sutured (Cytoplast 6/0 PTFE) to fix the flap in position. The interim restoration was cemented onto a Ti-base (CONELOG Titanium base CAD/CAM crown, CAMLOG) with a resin cement (SpeedCEM plus, Ivoclar Vivadent). This customised healing abutment placed immediately after the implant placement covered exactly the extraction wound and helped in maintaining the soft-tissue contours. A control radiograph confirmed the right position of the implant, the position stability of the shield and the correct distance from the tooth shield to the implant (Figs. 8a & b). After 2.5 months of healing, an optimal soft-tissue emergence profile was obtained (Fig. 9) and final restoration was delivered after 10 weeks (Figs. 10–12). Six months after insertion of the final restoration the crown is perfectly integrated (Fig. 13).

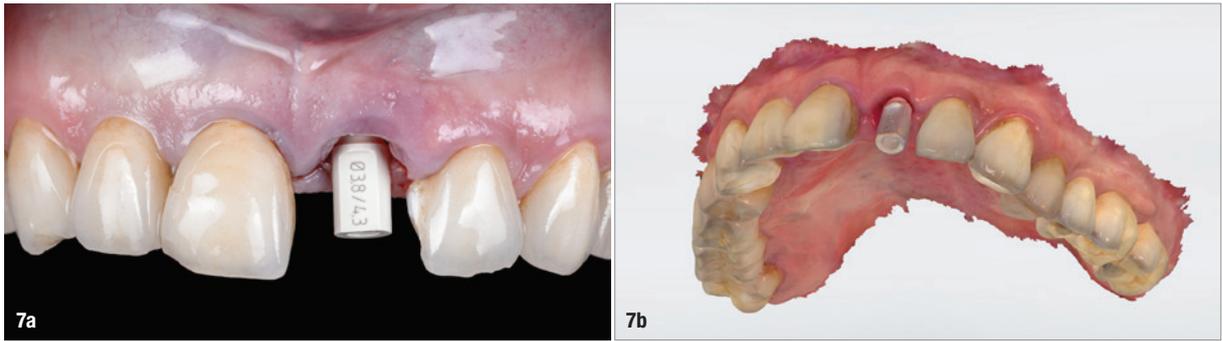
Figs. 7a & b: A scan body is used to immediately register the 3D position of the implant.

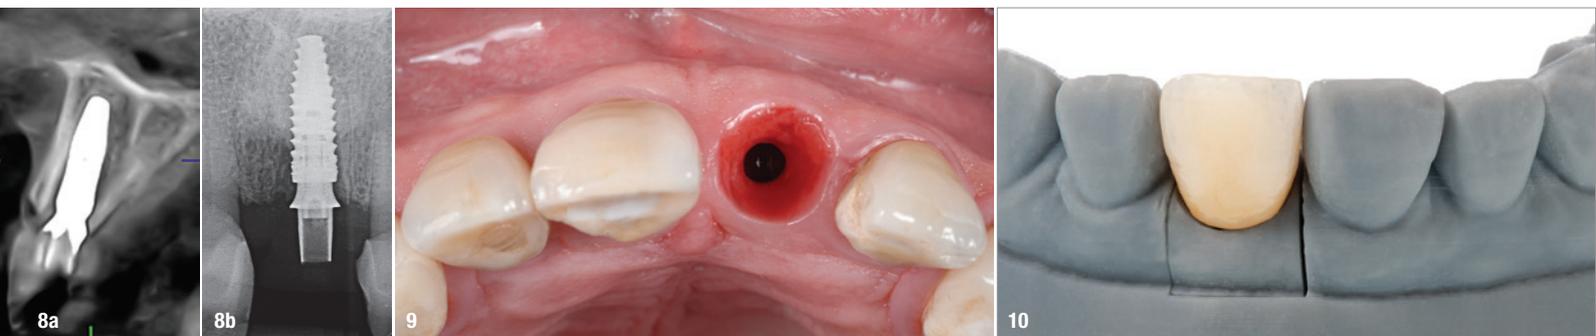
Figs. 8a & b: Radiological control of the position of the buccal root remnant and the implant. **Fig. 9:** After 8 weeks and removal of the provisional restoration the peri-implant region impresses by a voluminous and healthy soft tissue. **Fig. 10:** The final zirconia crown was produced following a fully digital workflow.

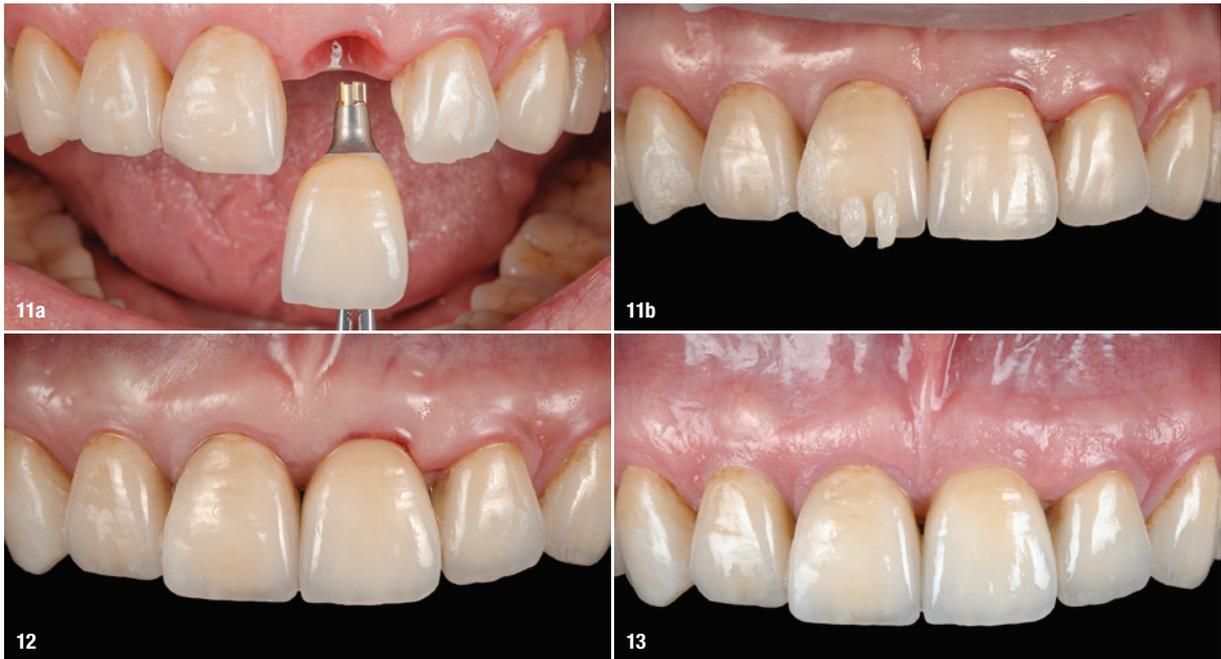
Figs. 11a & b: After seating the final prosthesis, slightly chipped adjacent crowns were repaired with composite. **Fig. 12:** Final situation the day the crown was delivered. **Fig. 13:** Follow-up 6 months later.
