# Immediate placement and loading of ceramic implants in the aesthetic region: One-year follow-up—two case reports

Drs Alexandre Marques Paes da Silva, Dennis de Carvalho Ferreira, Thamires Alves Silva, Mayla Kezy Silva Teixeira, Daniel de Moraes Telles & Eduardo José Veras Lourenço, Brazil

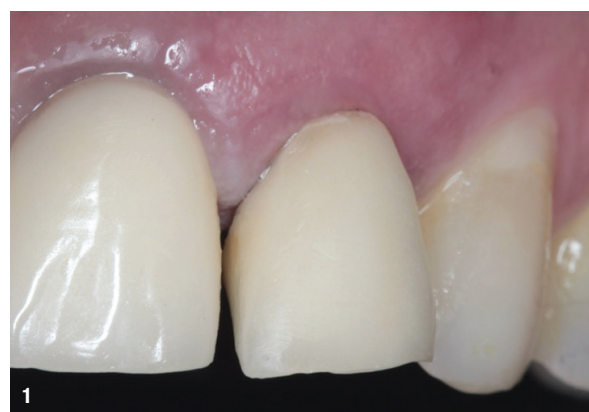
Fig. 1: Situation on initial clinical examination.

A 66-year-old female patient who was a smoker presented with the main complaint of a broken anterior tooth. On clinical examination, it was noted that the maxillary left lateral incisor had a metal-ceramic crown with a partially displaced cast metallic core (Fig. 1). The CBCT examination showed the presence of a vertical root fracture due to recurrent caries (Fig. 2). Given the clinical and radiographic situation, the proposed treatment was the extraction of the tooth in question, followed by immediate placement of a ceramic implant and immediate restoration with a crown.

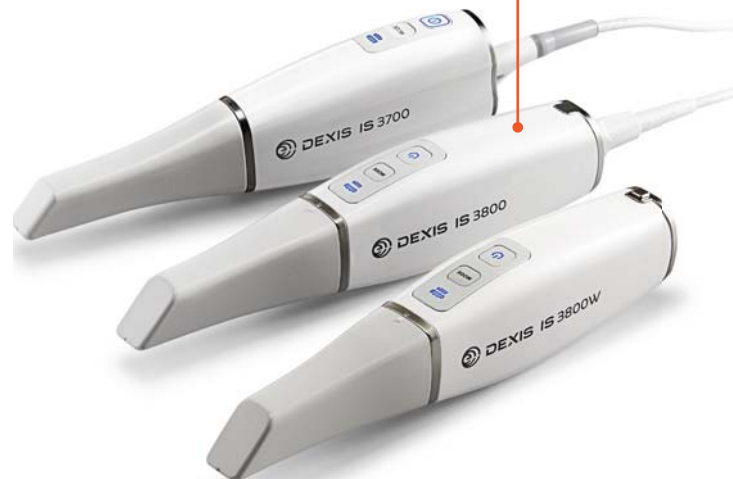
**Fig. 3:** Placement of the Zi implant. **Fig. 4:** Filling of the gap with bone grafting material. **Fig. 5:** Cemented zirconia abutment. **Fig. 6:** Immediate post-op situation with the provisional crown cemented.

The extraction was performed atraumatically with the aid of periostomes and forceps and a 3.75 × 13.0mm two-piece ceramic implant (Zi, Neodent) was placed in the fresh alveolus (Fig. 3). The insertion torque was 35Ncm, and this primary stability allowed for immediate loading. It should be noted that the implant was placed according to the manufacturer's recommendations at the level of the bone crest, and the gap was filled with bone substitute (maxresorb, botiss biomaterials; 0.5cm<sup>2</sup> of 0.5–1.0mm; Fig. 4). A 4.5 × 5.0 × 2.5mm (regular) zirconia abutment (Zi CR abutment) was seated (Fig. 5), and a provisional restoration was made with light-polymerising composite resin and cemented on the abutment (Fig. 6). At the end of the surgical procedure, a radiograph was taken (Fig. 7).

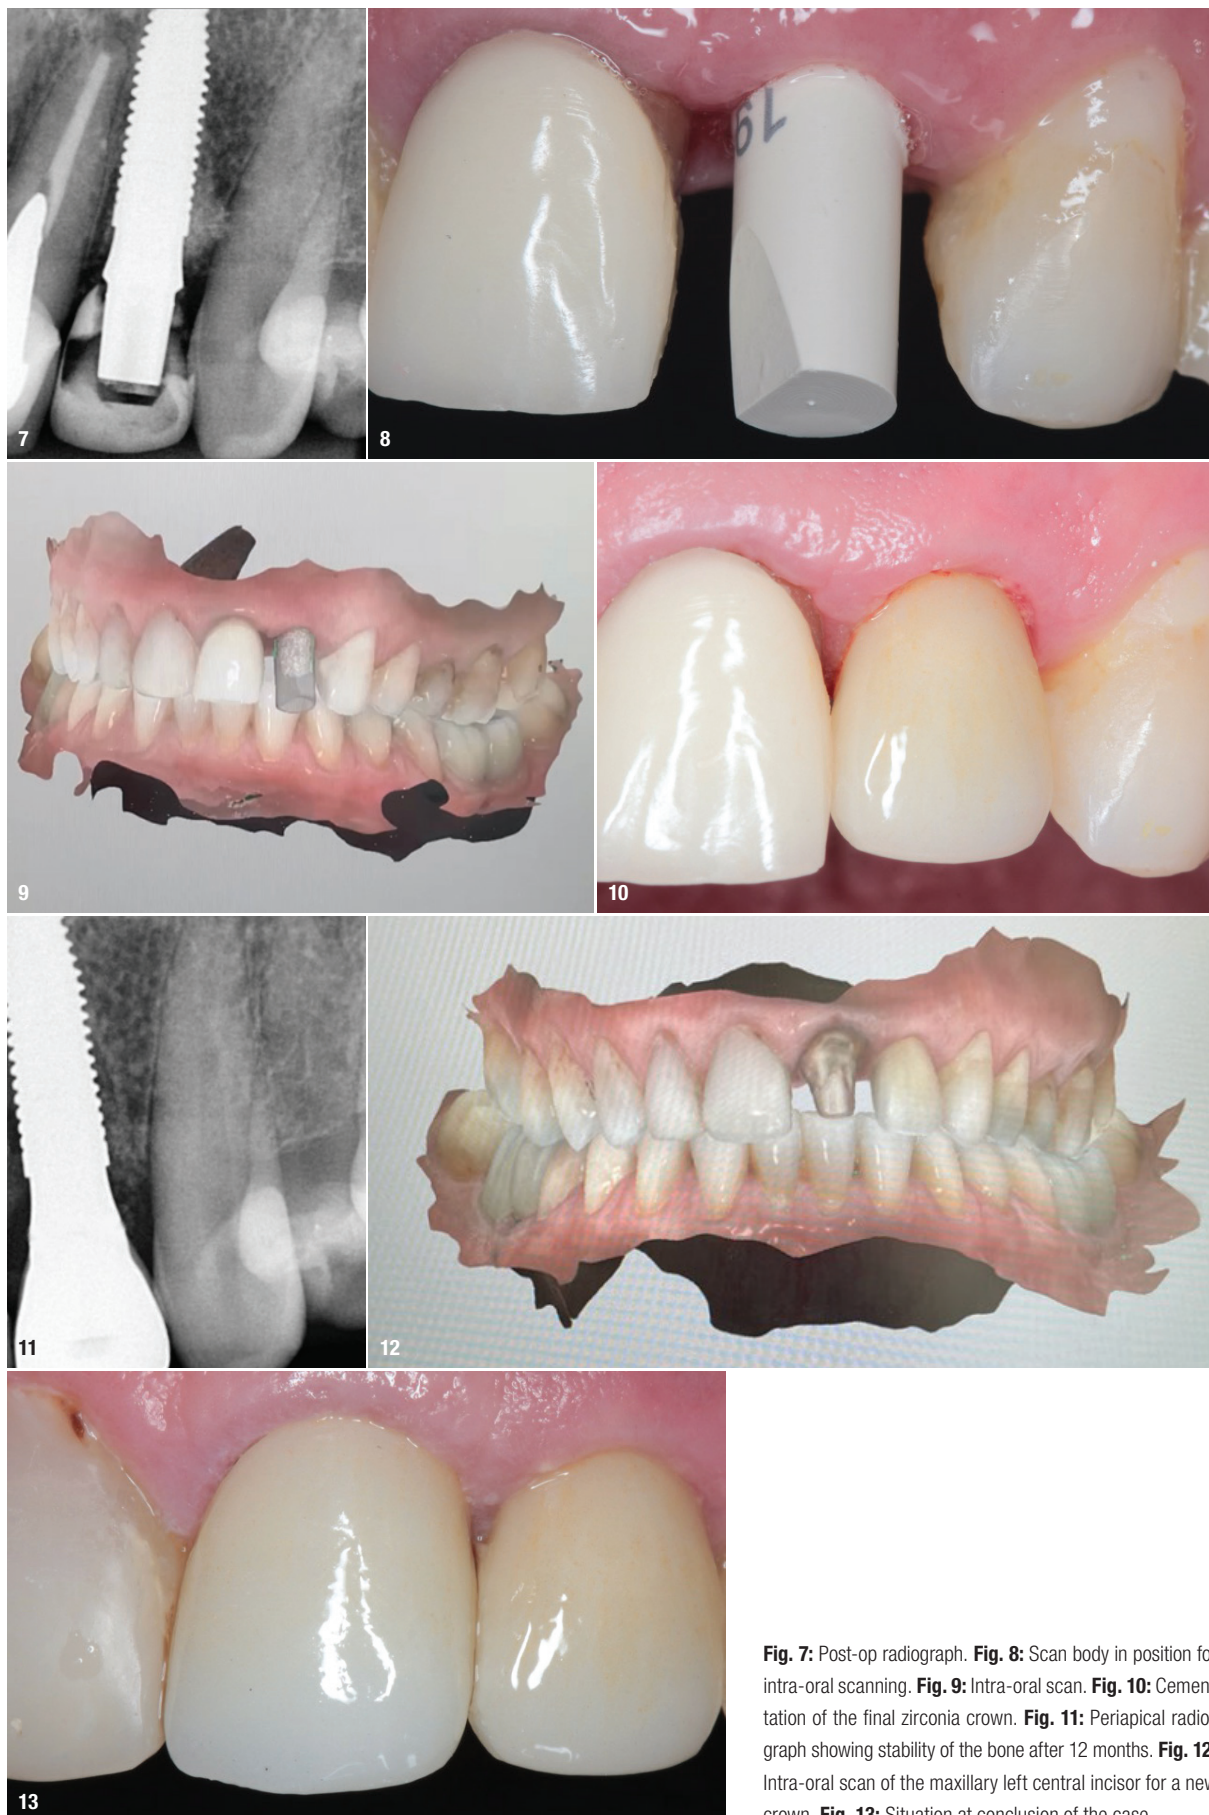
**Fig. 7:** Post-op radiograph. **Fig. 8:** Scan body in position for intra-oral scanning. **Fig. 9:** Intra-oral scan. **Fig. 10:** Cementation of the final zirconia crown. **Fig. 11:** Periapical radiograph showing stability of the bone after 12 months. **Fig. 12:** Intra-oral scan of the maxillary left central incisor for a new crown. **Fig. 13:** Situation at conclusion of the case.

The three-month postoperative period was uneventful, and after this period, the patient returned to begin the final prosthetic phase. The final prosthesis was fabricated from monolithic zirconia using a digital workflow (Virtuo Vivo intra-oral scanner, Straumann; Figs. 8 & 9) and cemented on to the abutment with a dual adhesive cement (RelyX U200, 3M; Fig. 10). After 12 months of follow-up, the periapical radiograph showed the stability of the bone (Fig. 11).

After cementing the crown, it was observed that a new crown was needed for the adjacent tooth, the maxillary left central incisor, owing to the discrepancy in colour and dental anatomy. This prosthesis was also fabricated from monolithic zirconia using a digital workflow (Fig. 12) and cemented onto the prepared tooth with a dual adhesive cement (RelyX U200; Fig. 13).

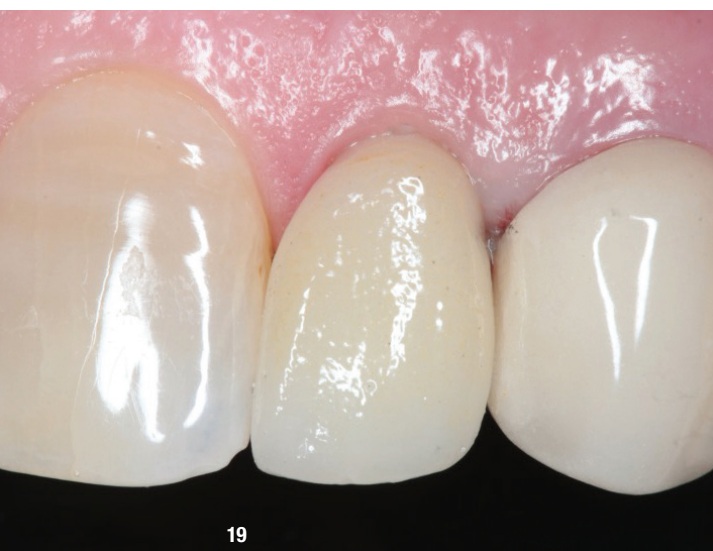
**Fig. 19:** Cementation of the final lithium disilicate crown. **Fig. 20:** Healthy soft tissue around the implant.

The three-month postoperative period was uneventful, and after this period, the patient returned to begin the final prosthetic phase. The final prosthesis was fabricated from lithium disilicate (IPS e.max, Ivoclar Vivadent) using an analogue workflow with impression material (addition-cured silicone, Yller) and cemented on to the abutment with a dual resin cement (RelyX U200; Fig. 19). Prior to cementation, the health of the peri-implant tissue around the ceramic implant was observed, as was the maintenance of the soft tissue, including the mesial and distal papillae (Fig. 20). After 12 months, the patient returned and a radiograph was taken, on which the maintenance of the bone around the implant was observed (Fig. 21).

tanium implants.<sup>12,13</sup> Furthermore, zirconia, like titanium, is a biocompatible material and favours the health of the peri-implant soft tissue,<sup>14</sup> as was observed after 12 months of follow-up in the two cases reported here. In Case 2, we observed the health of the soft tissue around the ceramic implant, particularly the collagen fibres present in the region.
