# Long-term success of implant-supported rehabilitation in the aesthetic zone: A nine-year follow-up case report

Drs Léon Pariente & Karim Dada, France

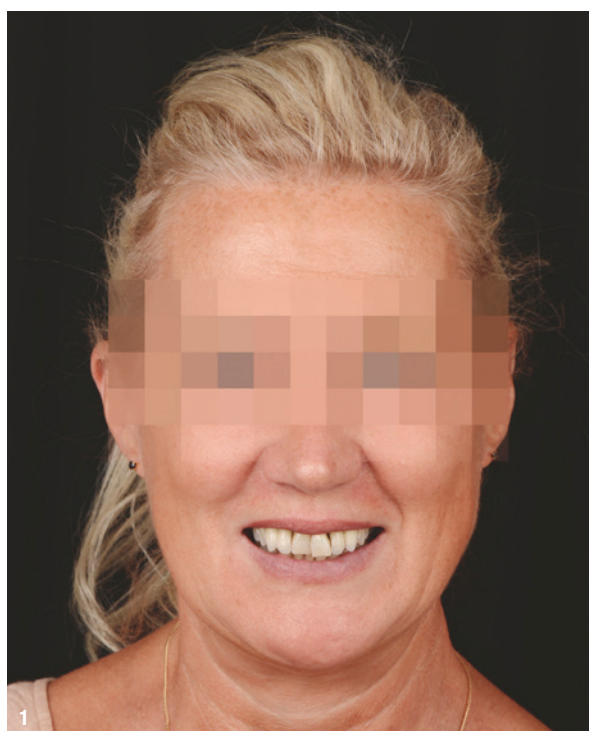
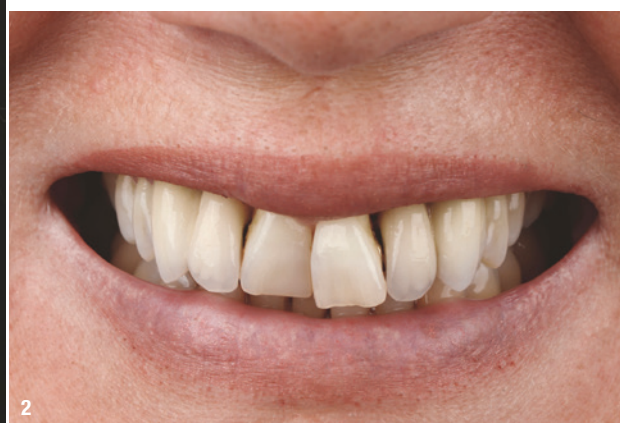
**Fig. 1:** The patient's extra-oral examination revealed a medium smile line. **Fig. 2:** Misalignment observed in the maxillary front teeth.

The patient's extra-oral examination revealed a medium smile line and misalignment of the front teeth (Figs. 1 & 2). During the intra-oral examination, advanced periodontal attachment loss and mobility were noted in teeth #12, #21, and #22 (Fig. 3). Cone-beam computed tomography (CBCT) imaging indicated the absence of buccal bone on tooth #21 (Fig. 4).

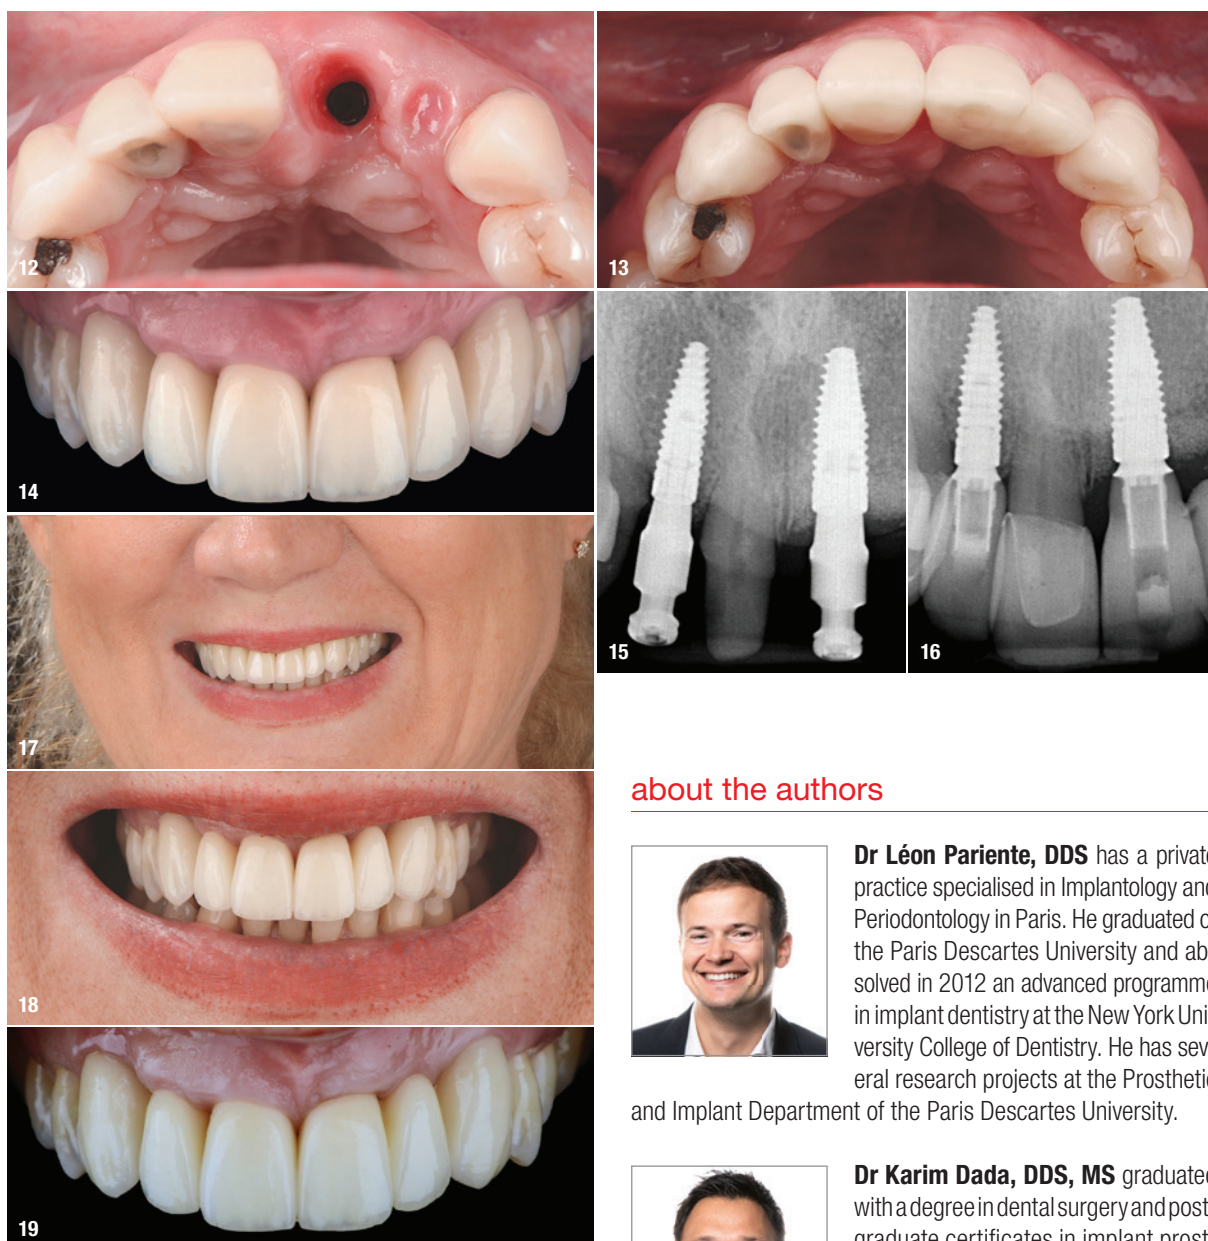
**Fig. 12:** Successful soft-tissue healing observed at the seven-month follow-up. **Fig. 13:** Placement of the final restorations. **Fig. 14:** The aesthetically pleasing appearance of the final crowns. **Fig. 15:** Radiographic assessment at the time of final impression confirmed precise implant placement and verified bone structure integrity. **Fig. 16:** A follow-up radiographic evaluation assessed the long-term stability and health of the implant sites. **Fig. 17:** Six-year follow-up showing favourable aesthetic results. **Fig. 18:** Six-year follow-up demonstrating a satisfactory clinical outcome. **Fig. 19:** Nine-year follow-up revealing successful results, with healthy soft and hard tissues maintained.

Soft-tissue conformation was evaluated seven months after the delayed loading of implant #21, with the aim to assess the maturation and adaptation of the surrounding soft tissues to the implant site (Fig. 12).

After the successful healing and osseointegration of both implants, the final restorations were placed on the implants, and the screws were tightened within the range of 15 to 35 Ncm revealing a natural and aesthetically pleasing appearance of the final crowns (Figs. 13 & 14).

Radiographic control was conducted at the time of the final impression to ensure an accurate assessment of the implant placement and surrounding structures (Fig. 15). Additionally, a follow-up radiographic evaluation was performed six years after the completion of the treatment to monitor the long-term stability and health of the treated area (Fig. 16).

At the six-year (Figs. 17 & 18) and nine-year (Fig. 19) follow-ups, comprehensive clinical and radiographic assessments underscored favourable outcomes, including osseointegration, the maintenance of bone density around the implants, and pleasing aesthetics. These findings collectively indicated the success of the long-term treatment.
